MASONRY ADVISORY COUNCIL

Ramblings and “Everything Changes with time.”

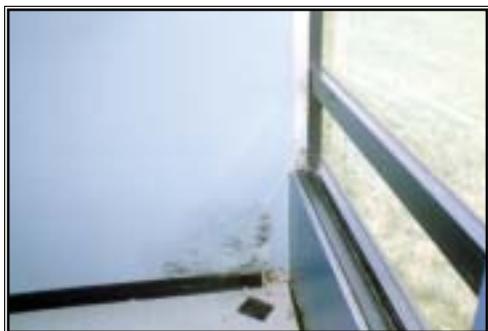
This 1 story local health care facility, built in the late 1970's had “water penetration problems” when it was repaired in the 1980's. Nowadays, it would have also necessitated a mold abatement program.

Notice the mold growing on the drywall near the floor.

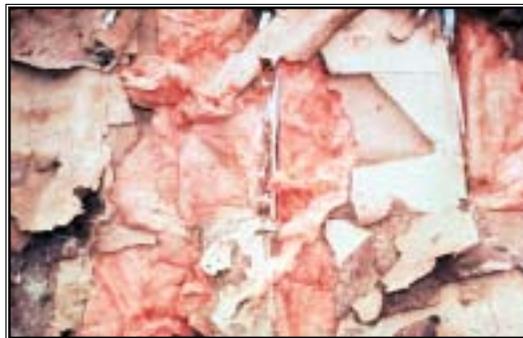
After the brick was removed one can see the corrosion of the steel studs, a black mold growing on the exterior paper of the drywall and saturated batt insulation at the base of the wall.
