**REQUEST FOR
CERTIFICATION OF
COMPLETED WORK**

**PHOTO
DOCUMENTATION OF
BUILDING AND SITE
RESTORATION
REQUIREMENTS
ACHIEVED**

**207 N. Academy
Street**

***Wisconsin Historical
Society***

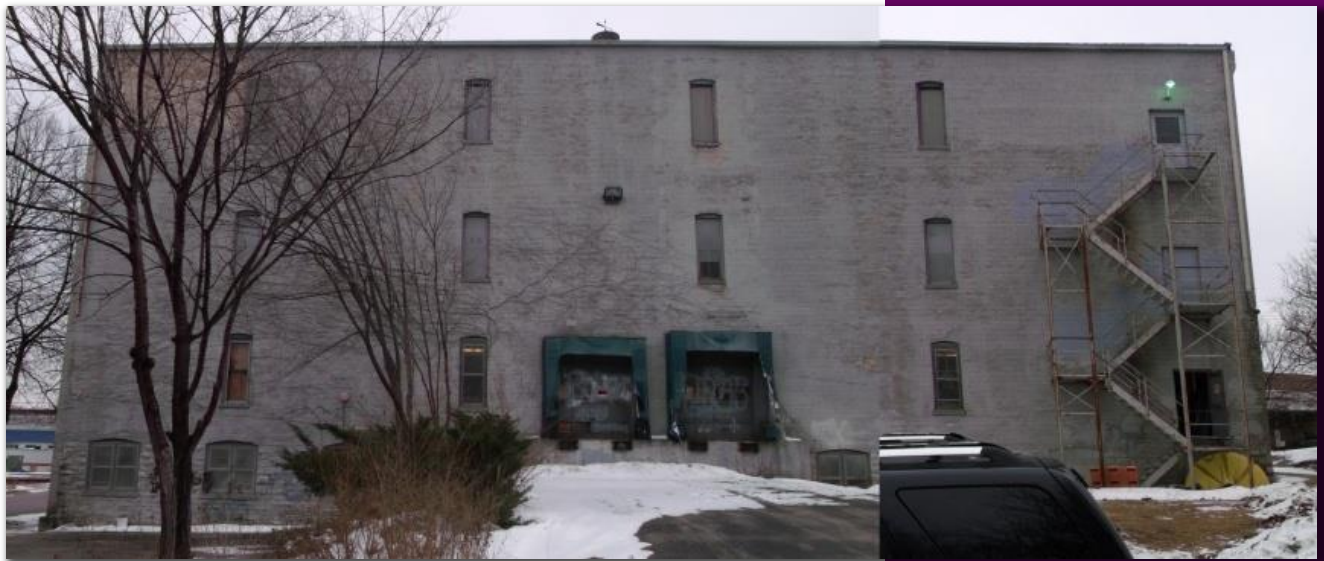
1. North Elevation - 2015

- The original stone & brick façade was cleaned, repaired, tuck-pointed and re-painted gray.
- The vast majority of existing window and door openings were preserved with minimal modifications made to a few of the opening sizes.
- The majority of the surrounding land grading has been preserved and the original elevation exposure remains.

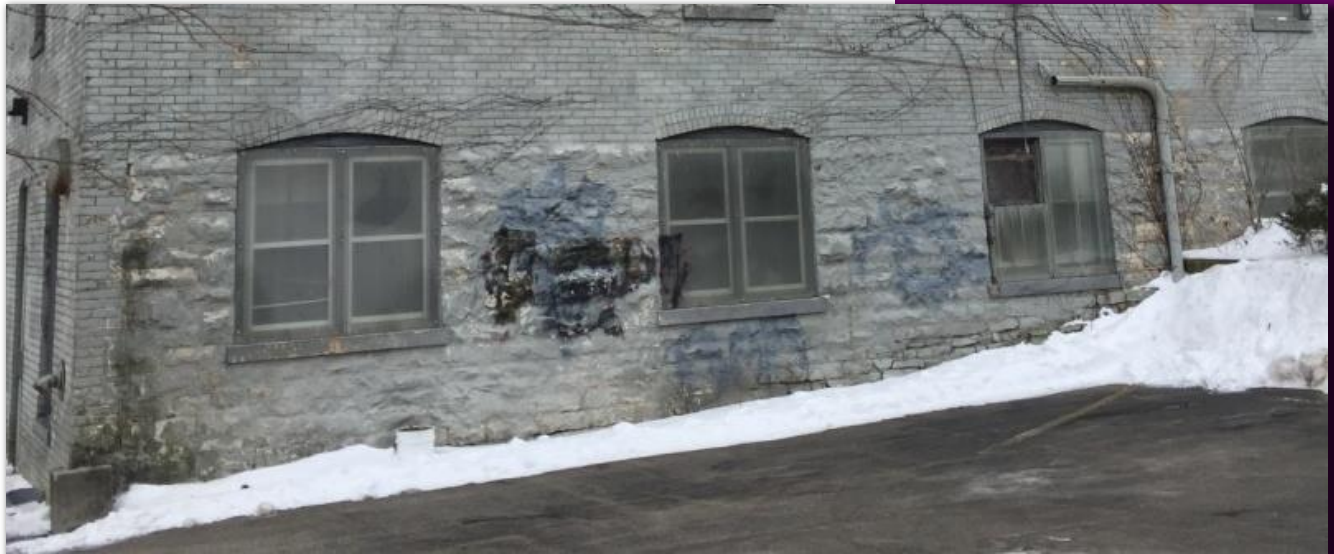
1. North East Corner – 2015

- All of the existing window and door openings on Levels 2, 3 & 4 were preserved with the exception of minimal modifications made to two opening sizes on level 2.
- Six of the original window openings on Level 1 were preserved with no modifications to the opening size or location.
- Two of the original window openings on Level 1 were modified to accommodate a new sprinkler room door and north entry door.

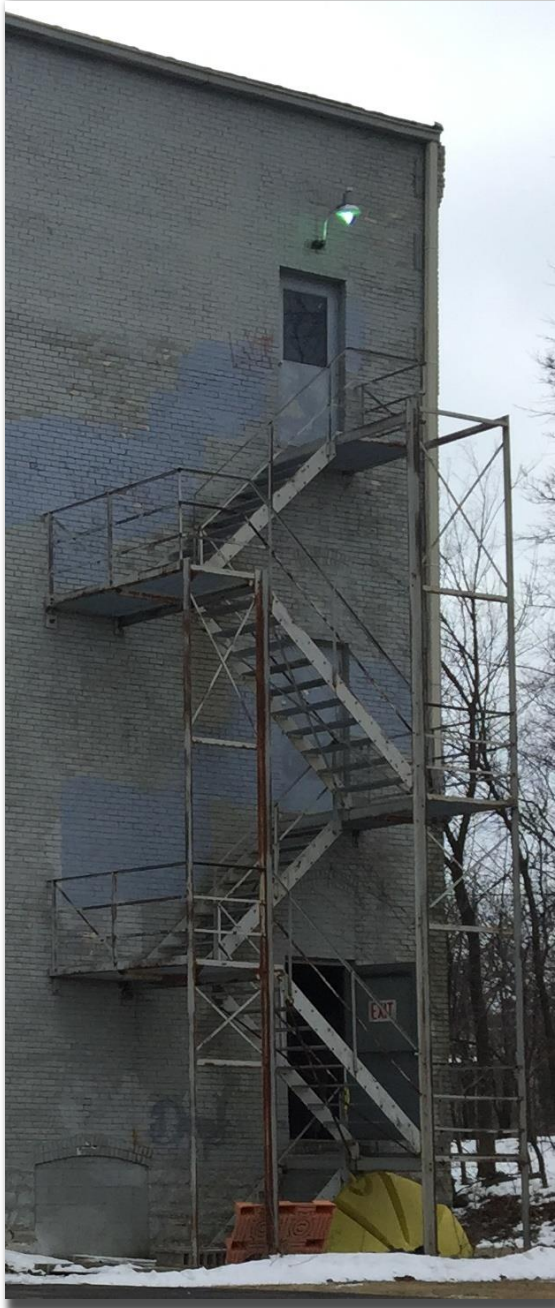
1. Exterior Steel Stair – 2015

- The Existing exterior steel stair was removed and replaced with a new steel stair in the same location.

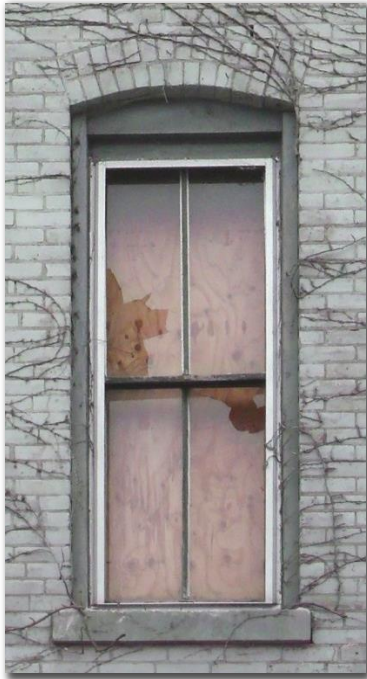
1. Window - 2015

- All of the existing window systems had failed and were replaced with new windows that replicate the original window design and proportions.

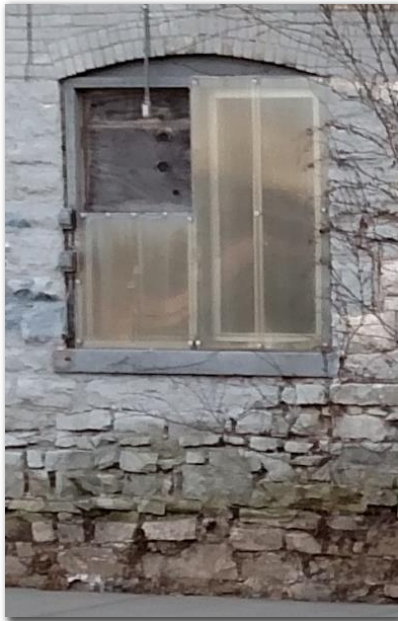
1. Window - 2015

- Two of the failed window systems were modified to accommodate the new sprinkler room entrance door and the north entry door.

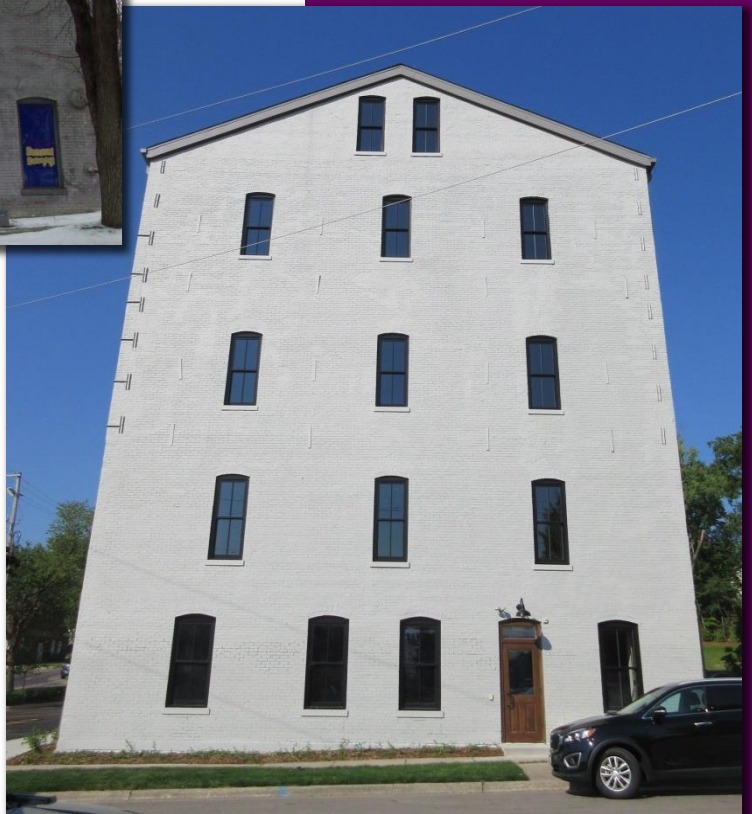
2. East Elevation - 2016

- The original brick façade was cleaned, repaired, tuck-pointed and re-painted gray.
- Existing openings for the windows and entry door were preserved with no modifications to the opening sizes or locations.

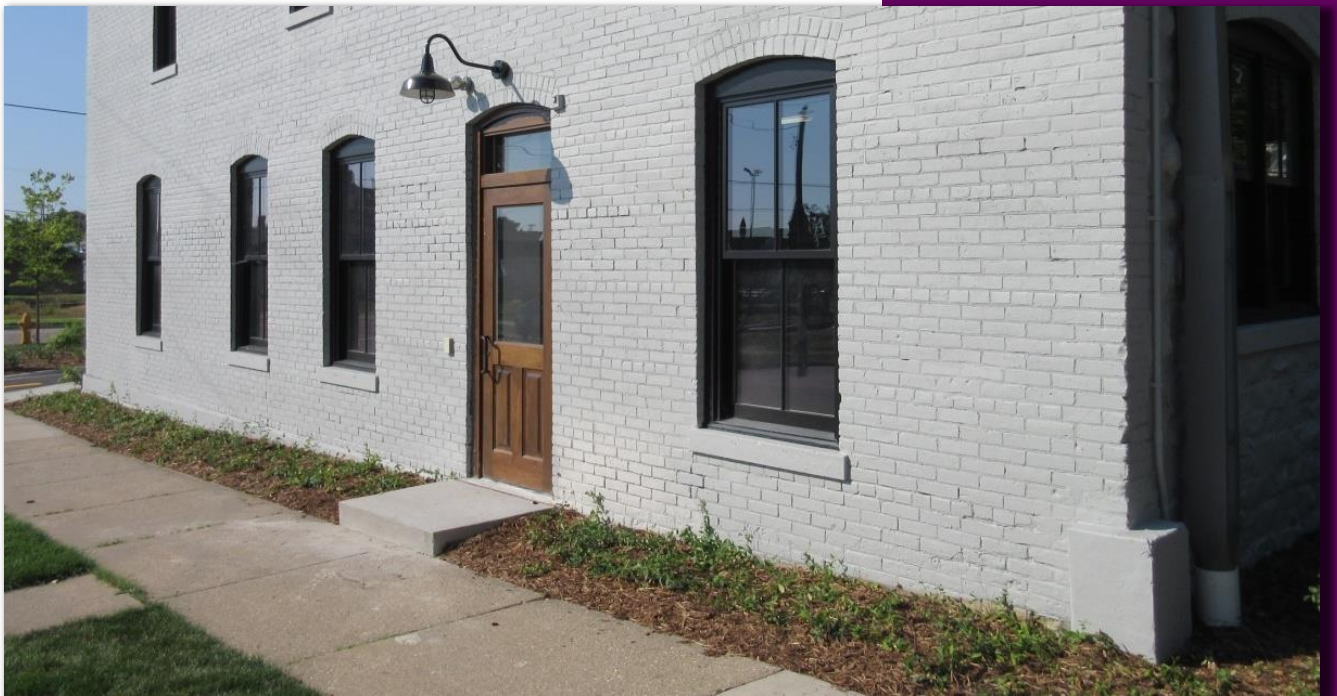
2. Level 1 Facade - 2016

- The surrounding land grading has been preserved and the original elevation relationships have been maintained.

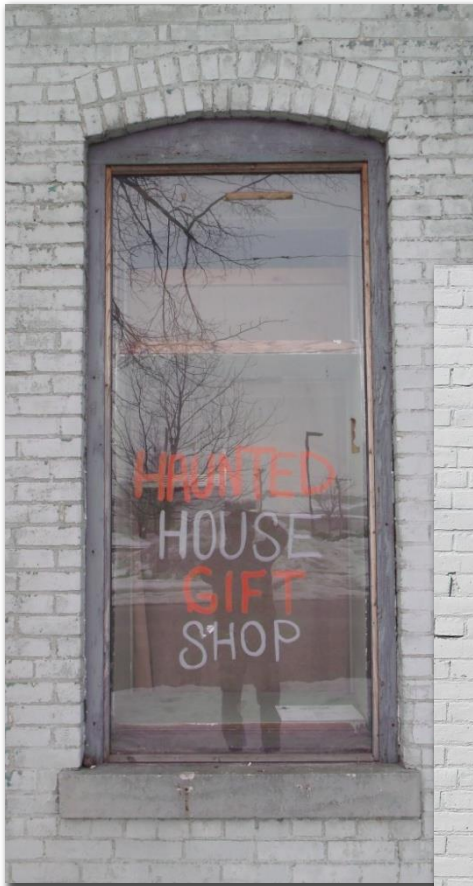
1. Window - 2015

- All of the existing window systems had failed and were replaced with new windows that replicate the original window design and proportions.

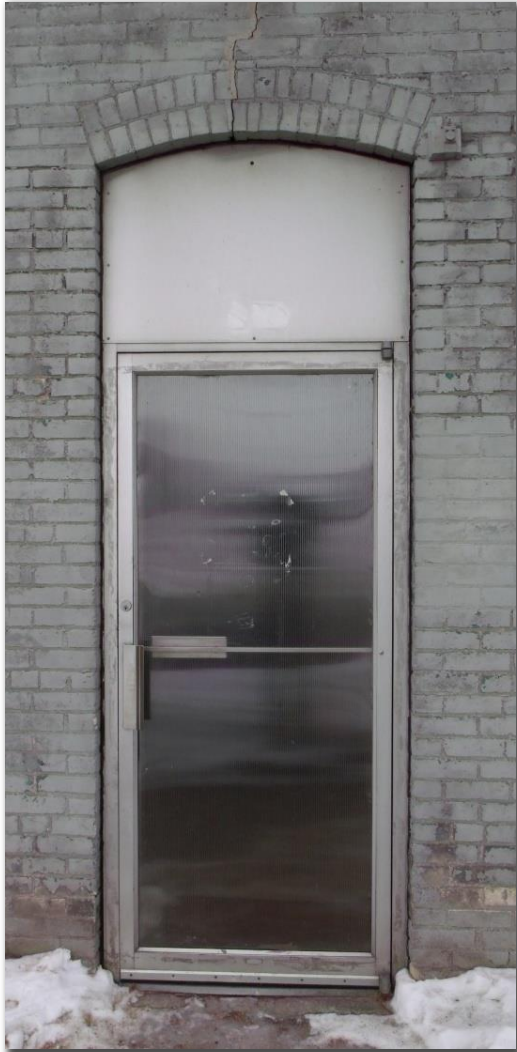
1. Entry Door - 2015

- The existing entry door was removed and replaced with a new entry door intended to replicate the style and design for all door openings.

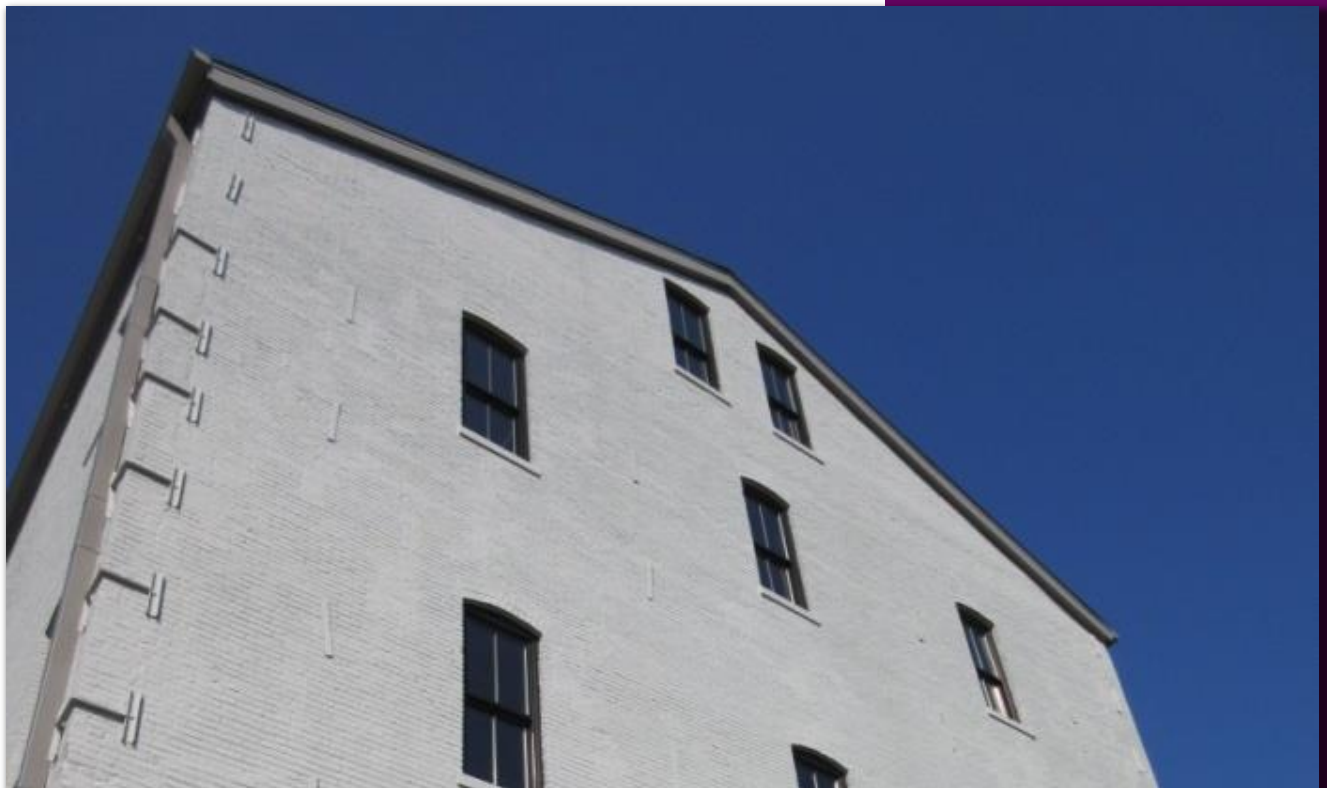
2. South East Corner - 2016

- The original steel reinforcing pieces located throughout the building façade and corners were preserved and re-painted gray to match the re-painted brick.

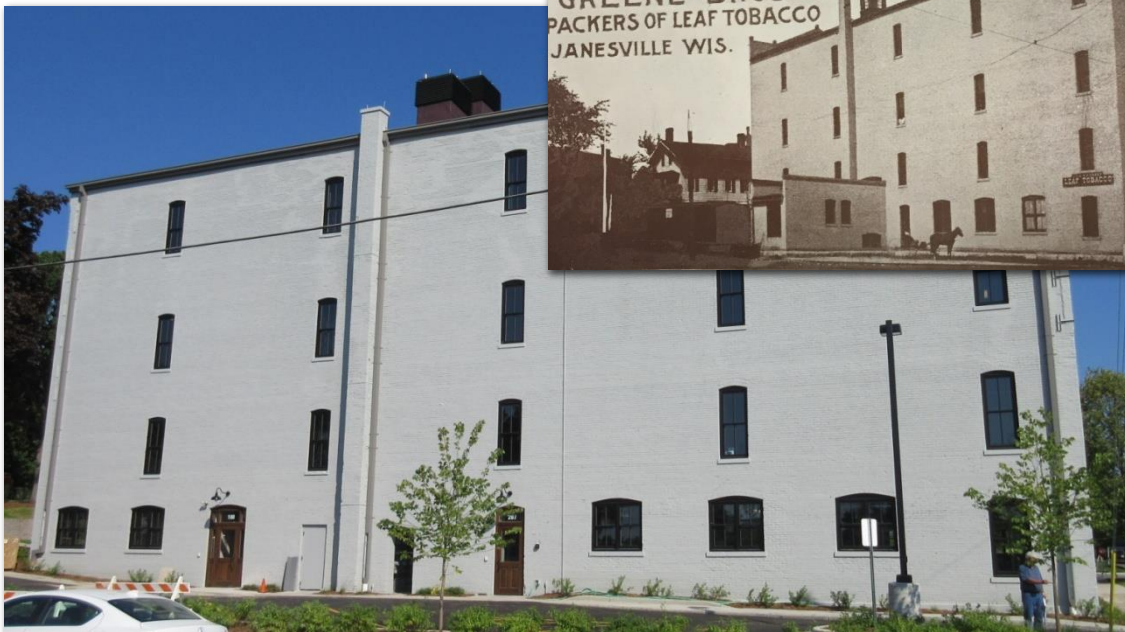
1. South Elevation - 2015

- The original brick façade and chimney was cleaned, repaired, tuck-pointed and re-painted gray.
- All of the original window openings on Levels 2, 3 & 4 were preserved with no modifications to the opening size or location.
- Seven of the original openings on Level 1 were preserved with no modifications to the opening size or location. Three of the original openings were modified to accommodate two new entry doors and a utility alcove entrance.

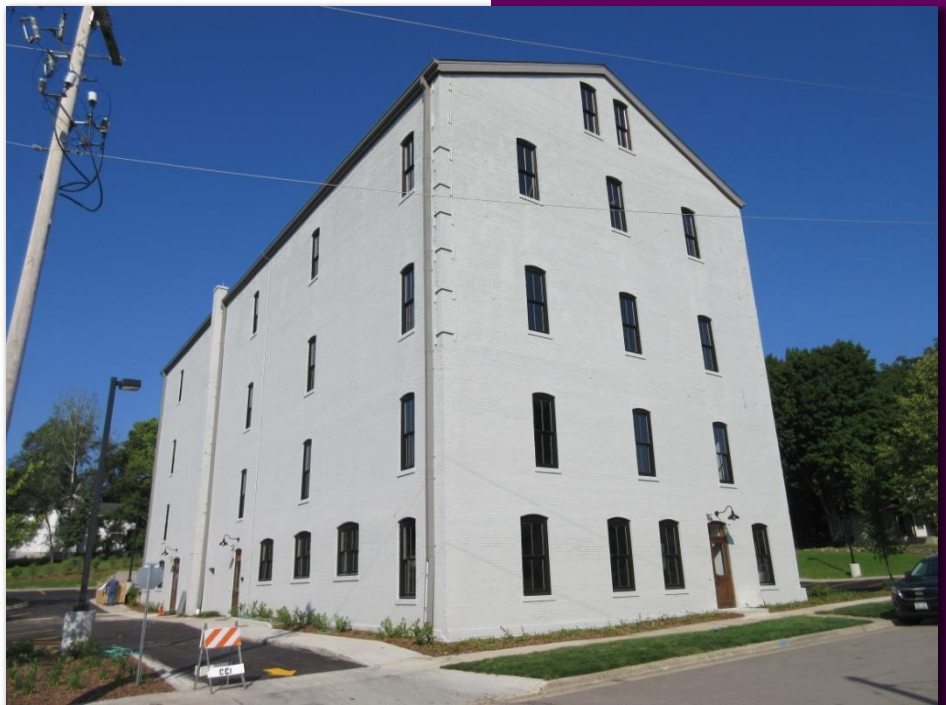
2. South East Corner - 2016

- The existing lean-to structure extending along the south façade was deemed a non-historic element of the building and was removed, restoring the south elevation to its original elevation composition.

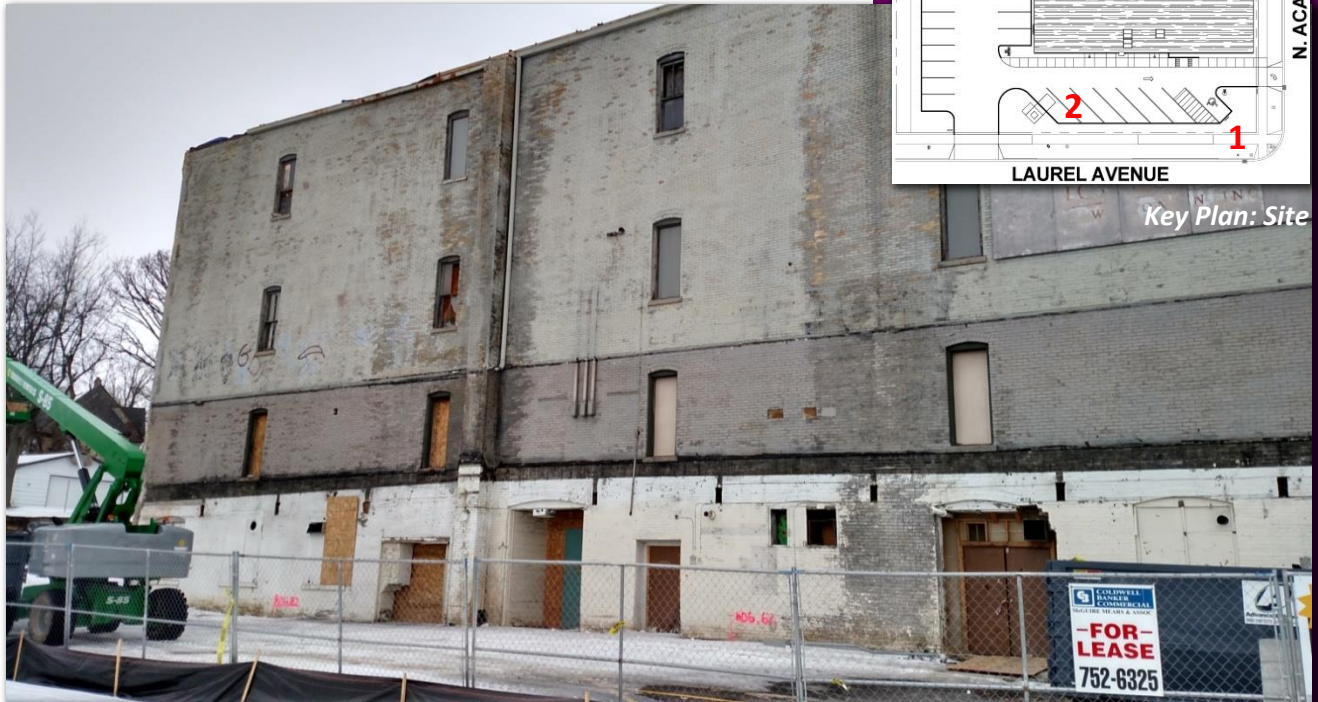
1. South Elevation - 2015

- Removal of the existing lean-to structure reveals level 1 & 2 original window and door openings.

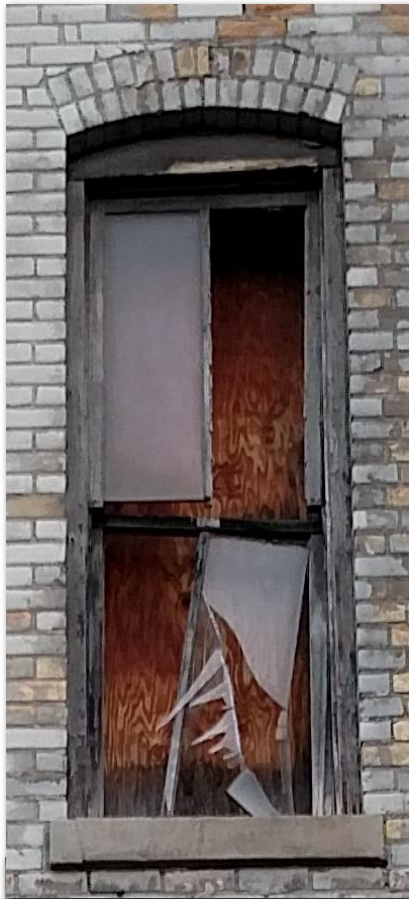
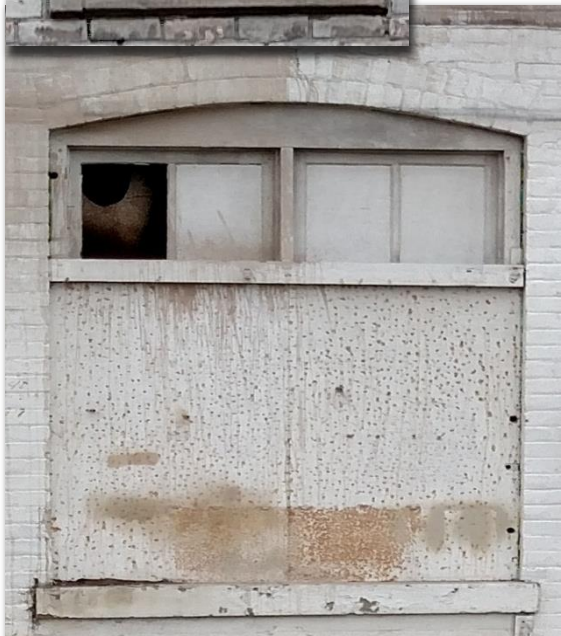
- All of the existing window systems had failed and were replaced with new windows that replicate the original window design and proportions.

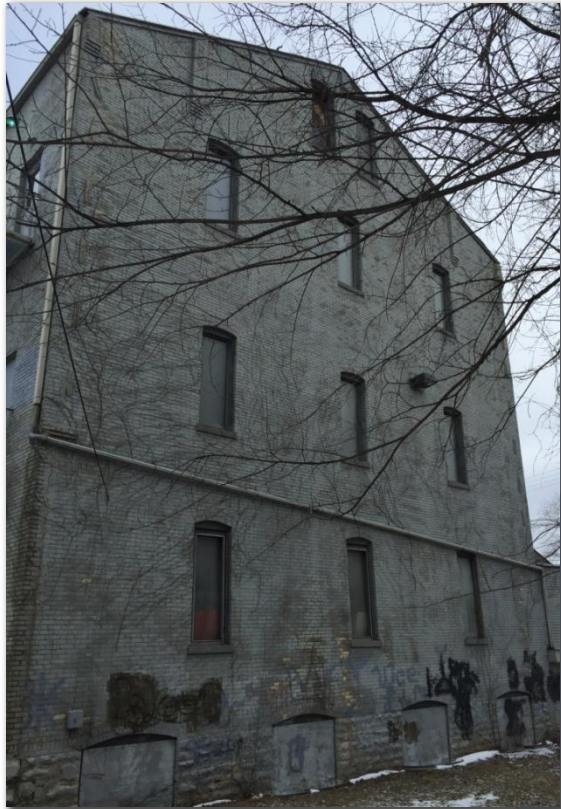
1. West Elevation – 2015

- The original brick façade was cleaned, repaired, tuck-pointed and re-painted gray.
- The original window openings were preserved with no modifications to the sizes or locations.

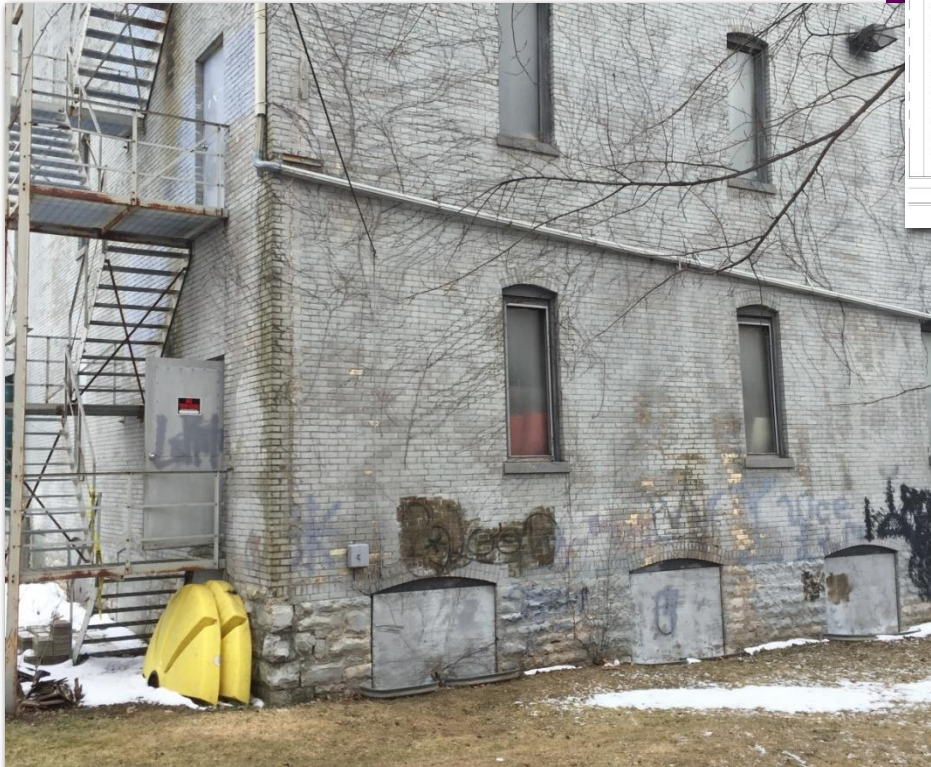
1. West Elevation – 2015

- The surrounding land grading has been preserved and the original elevation relationships have been maintained.

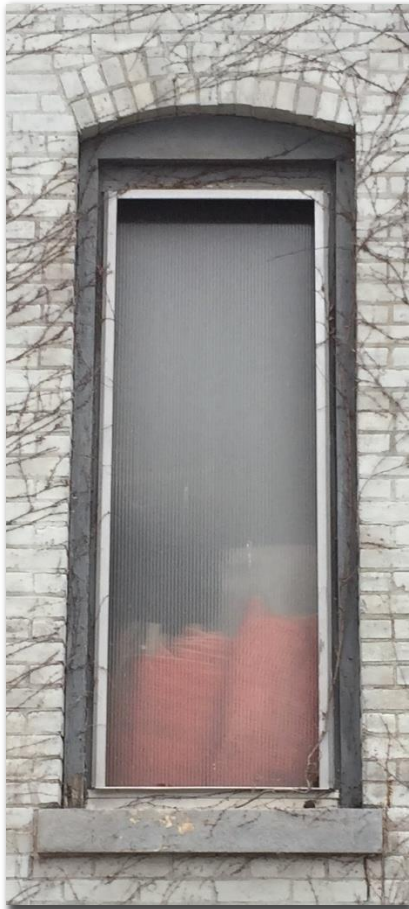
1. Window - 2015

- All of the existing window systems had failed and were replaced with new windows that replicate the original window design and proportions.

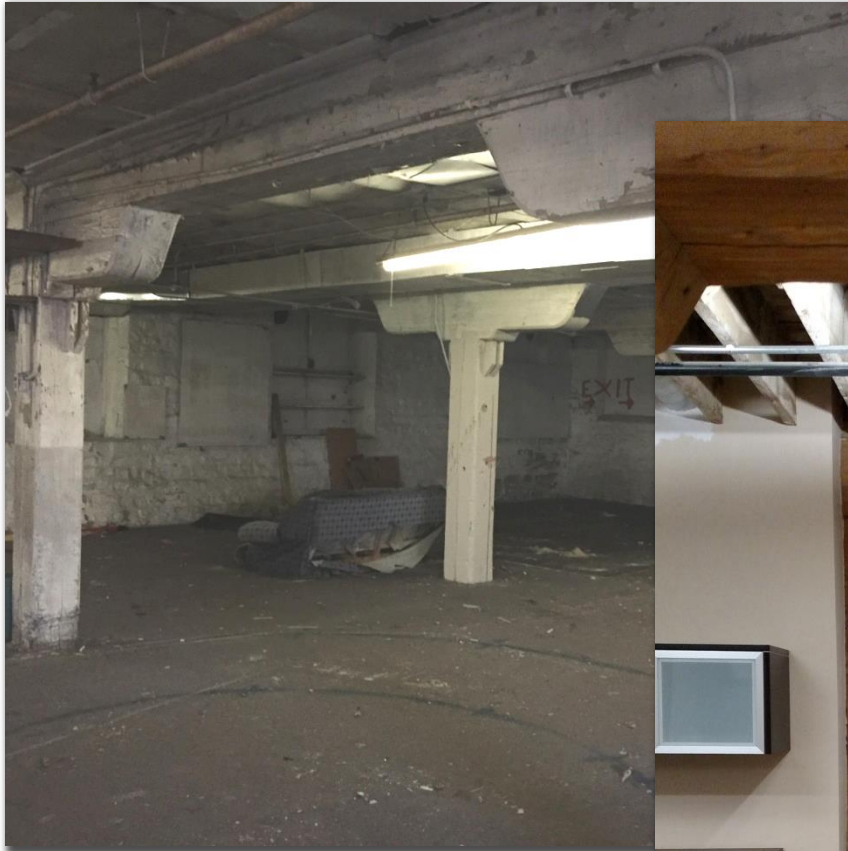
1. Level 1 – 2015

- The application of a new exposed concrete finish within the corridors and common areas was used to replicate the original building flooring.

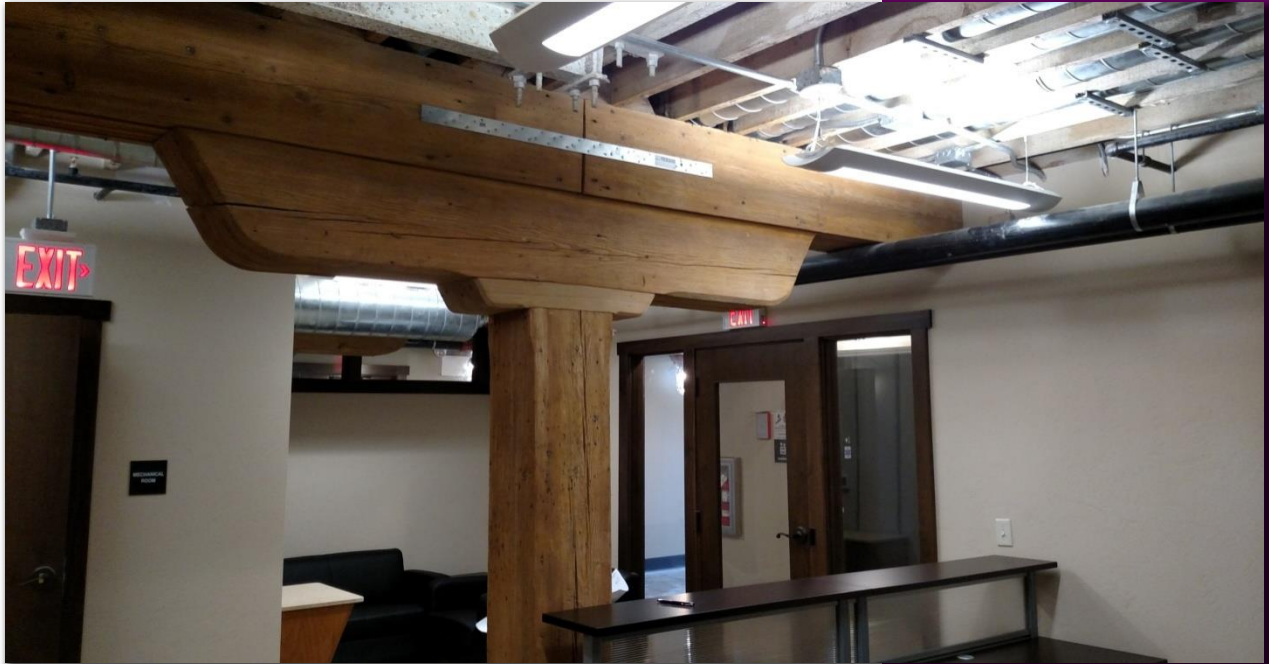
1. Waiting Area – 2016

- The positioning of new clerestory windows in the Waiting Area provides a visual connection between neighboring developed spaces.

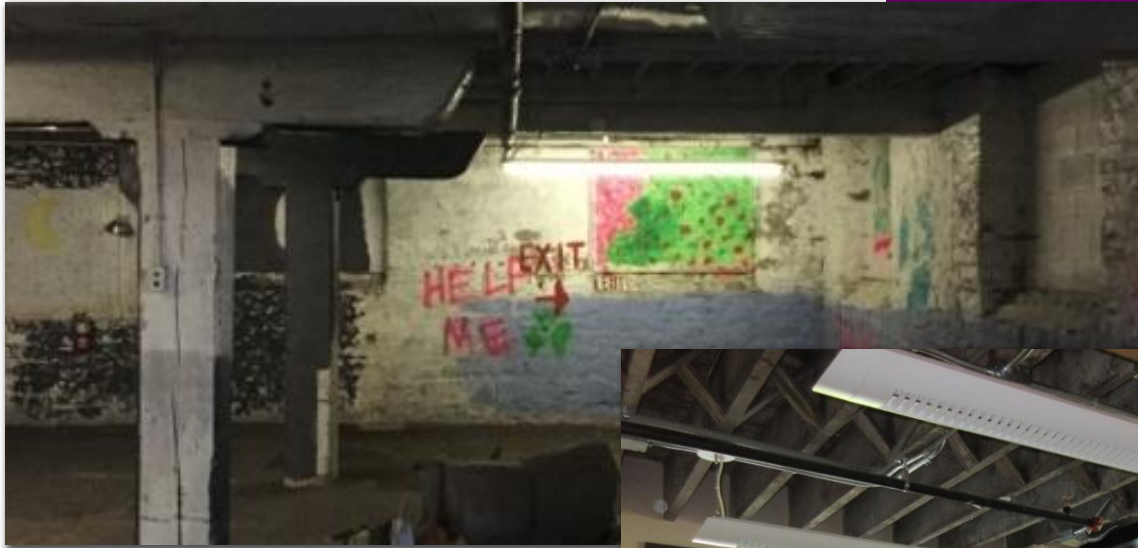
1. North West Corner – 2015

- All of the existing window systems had failed and were replaced with new windows that replicate the original window design and proportions.
- All new building elements that extend below the top of surrounding exterior windows are set back a minimum of five feet from the windows (example: light fixtures, diffusers, piping and walls) so that views are not obstructed.
- The original exterior stone walls have been finished out with metal studs, insulation and drywall in order to obtain a habitable climate controlled environment.

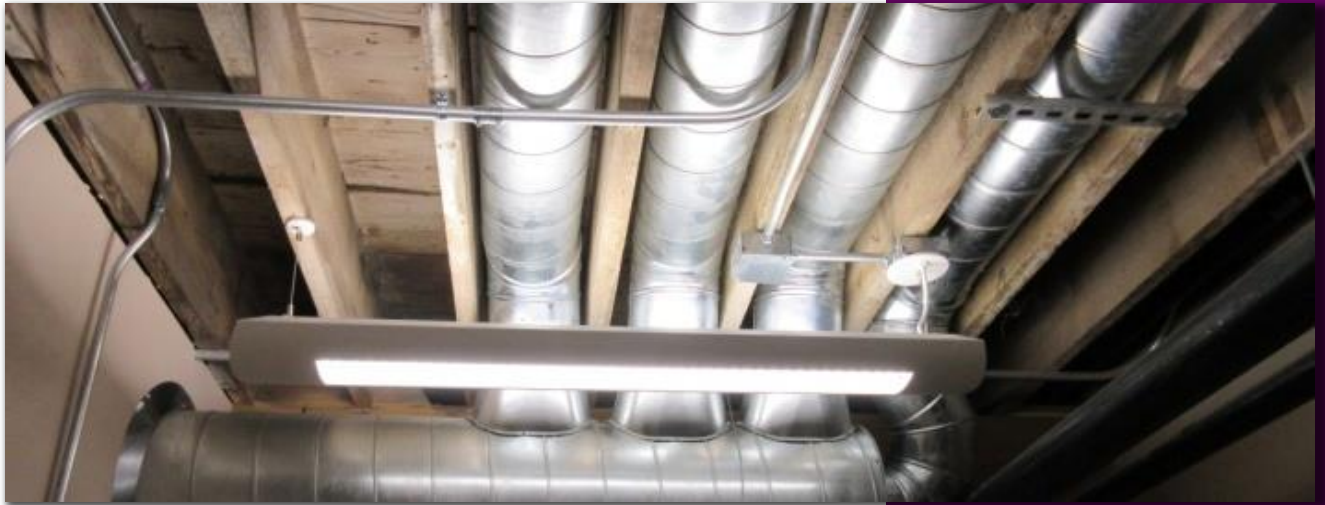
1. Exposed Wood Structure – 2016

- The original wood structural elements have been cleaned and remain exposed and prominent throughout all spaces.
- All piping, duct work and fixtures are positioned within and below the exposed wood floor structure above.

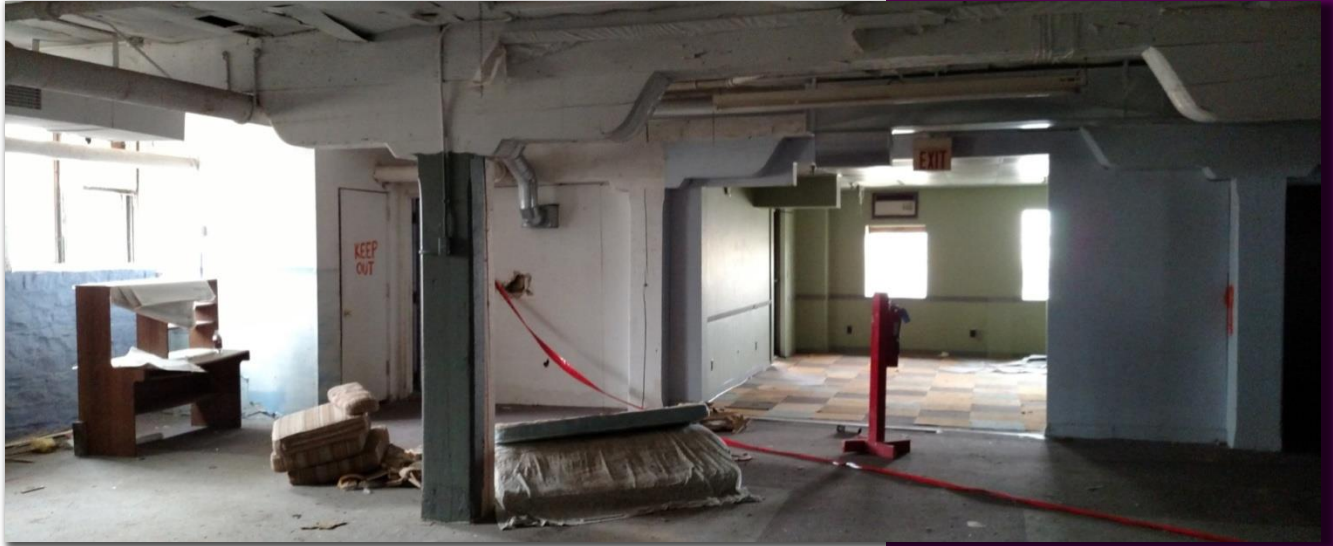
1. North East Corner - 2015

- The existing carpet and vinyl floor finish was removed.
- The application of a new exposed concrete finish throughout the entire space was used to replicate the original building flooring.

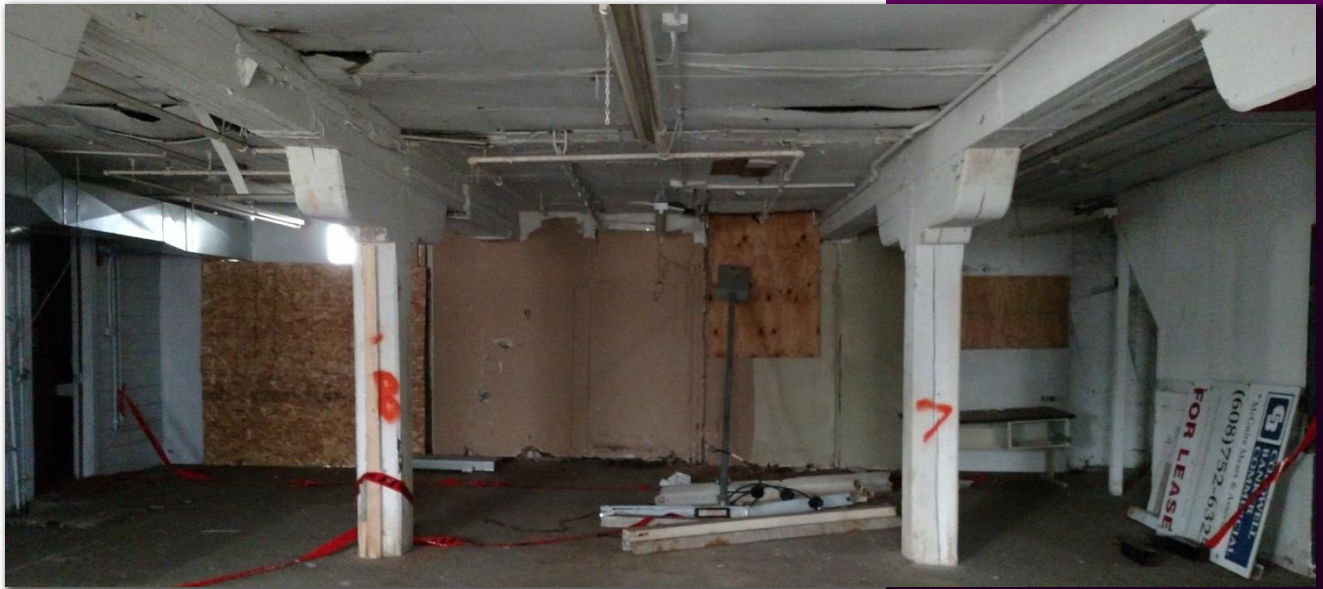
1. Ceiling - 2015

- The existing finished ceiling materials were removed and the original wood structural elements have been cleaned and remain exposed and prominent throughout all spaces.

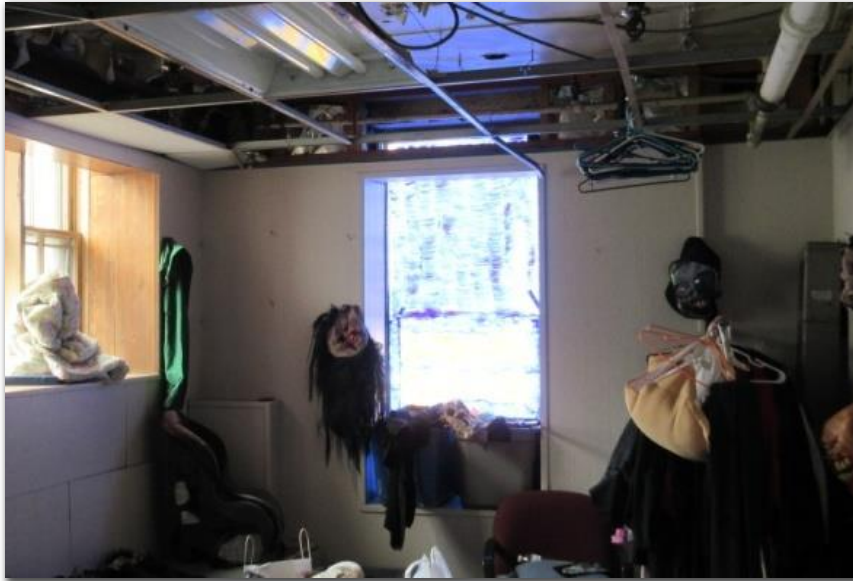
1. Windows - 2015

- All of the existing window systems had failed and were replaced with new windows that replicate the original window design and proportions.
- All piping, duct work and fixtures are positioned within and below the exposed wood structure.

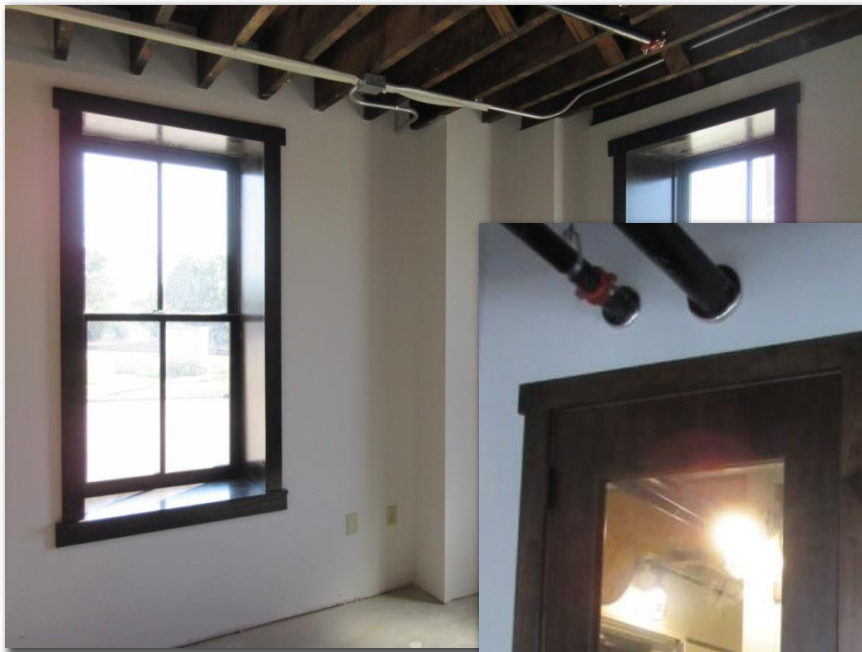
2. New Wall Furring - 2016

- The original exterior stone walls have been finished out with metal studs, insulation and drywall in order to obtain a habitable climate controlled environment.
- The positioning of new clerestory windows in the Waiting Area provides a visual connection between neighboring developed spaces.

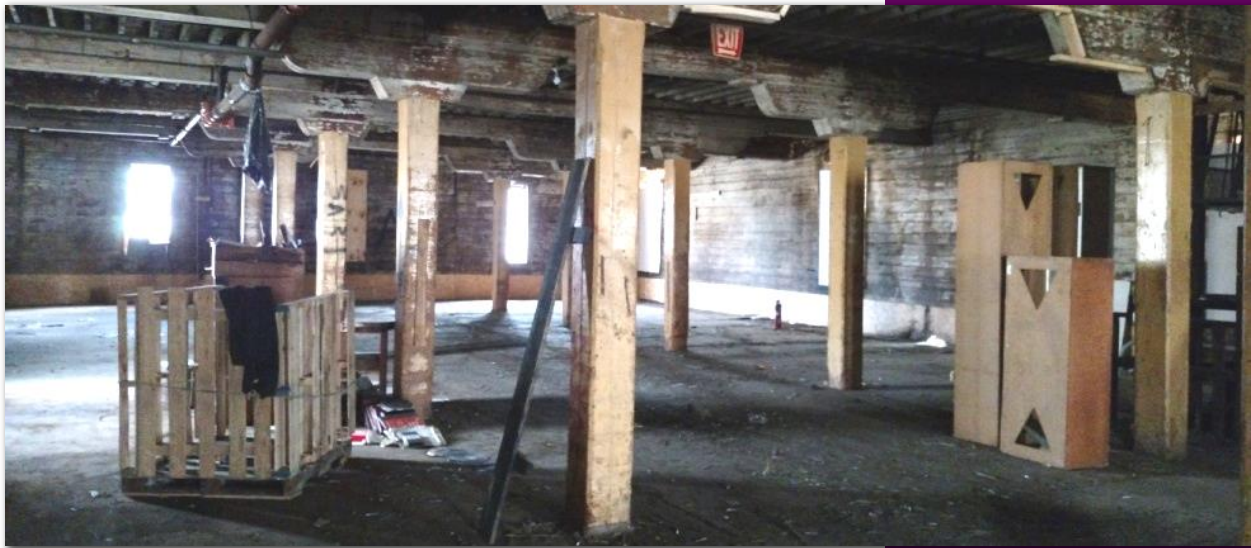
1. Southeast View - 2015

- Layers of existing flooring materials have been removed, exposing the original wood plank flooring below.
- A new composite OSB and finished natural wood flooring system was installed over the original wood plank flooring to accommodate code required life safety and structural standards.

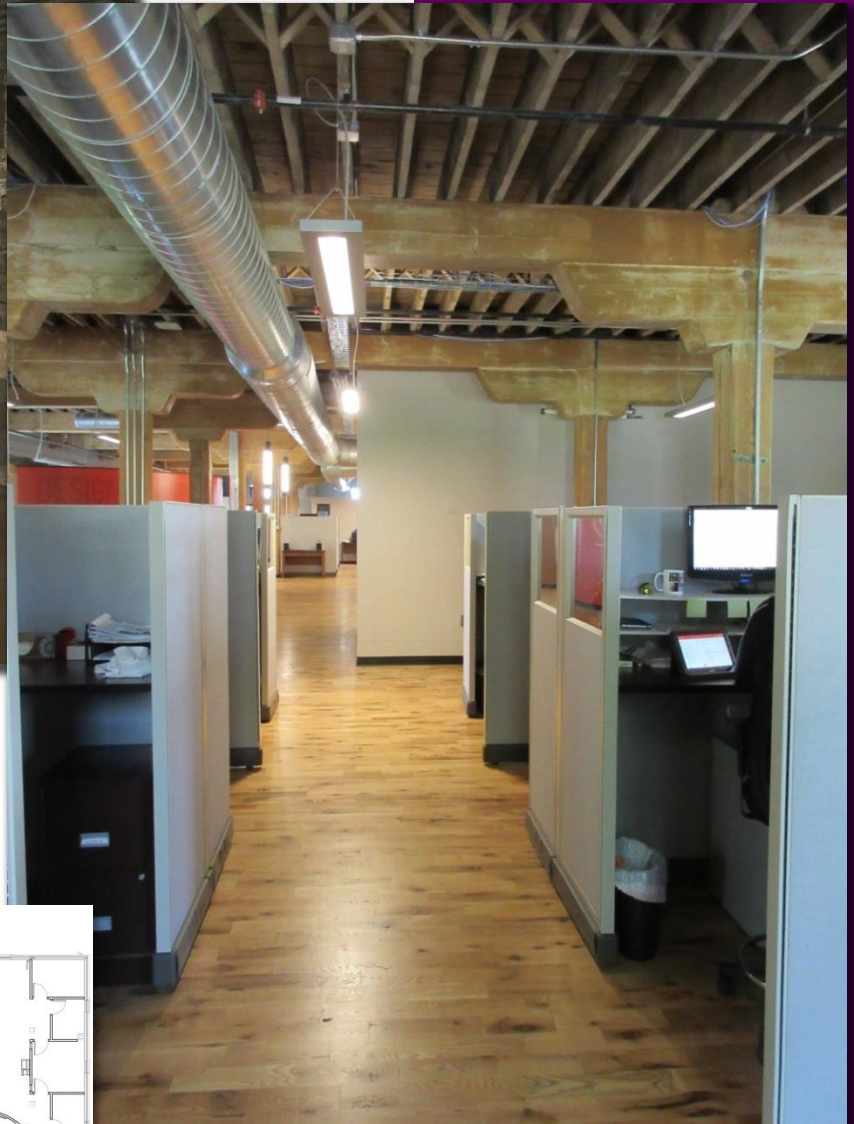
2. Wood Structure – 2016

- The original wood structure was cleaned and remains exposed throughout entire space.
- All piping, duct work and fixtures are positioned within and below the exposed wood floor structure above.

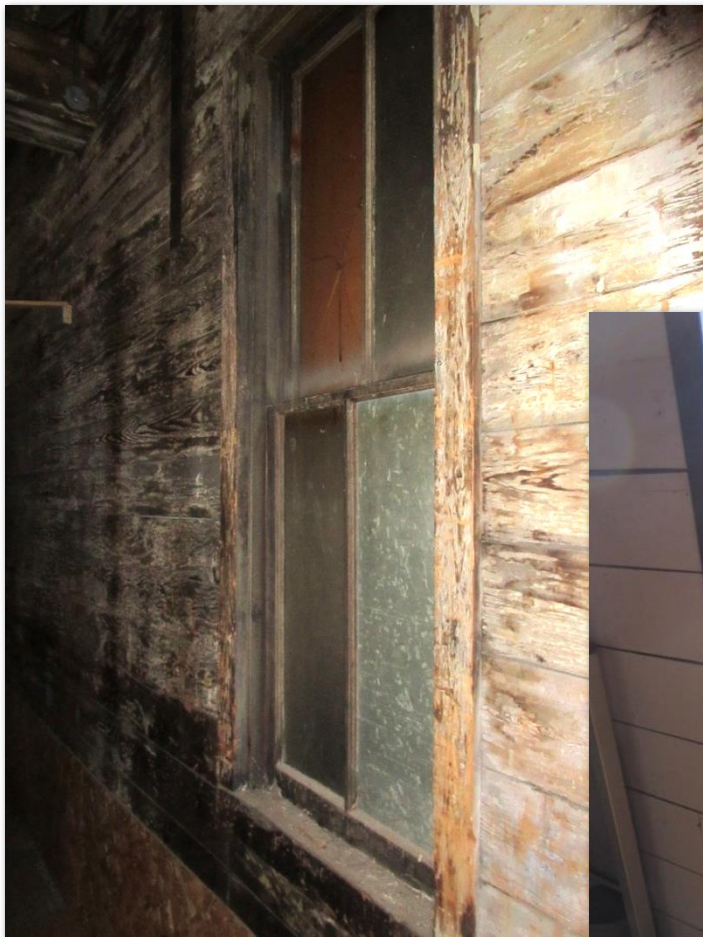
1. Wood Planks and Window - 2015

- The original wood wall planks located on the exterior walls were re-used in as close to the original location as possible and painted white.
- All of the existing window systems had failed and were replaced with new windows that replicate the original window design and proportions.

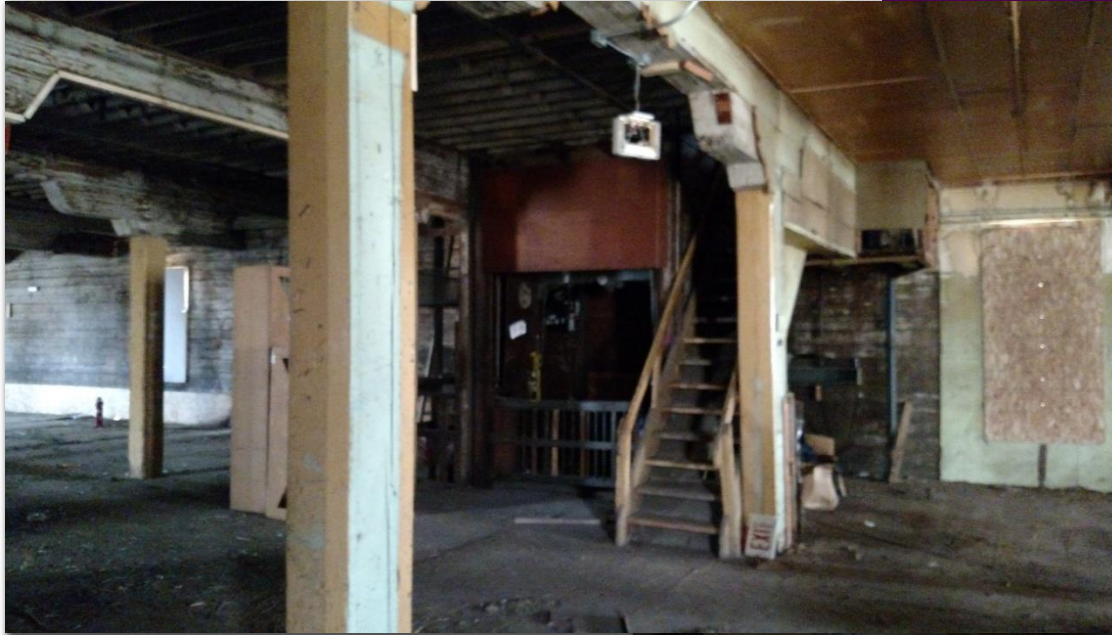
1. Stair & Elevator Core - 2015

- The new stair and elevator core are positioned alongside the original wood structure, preserving the original structural bay dimensions and north south beam locations.

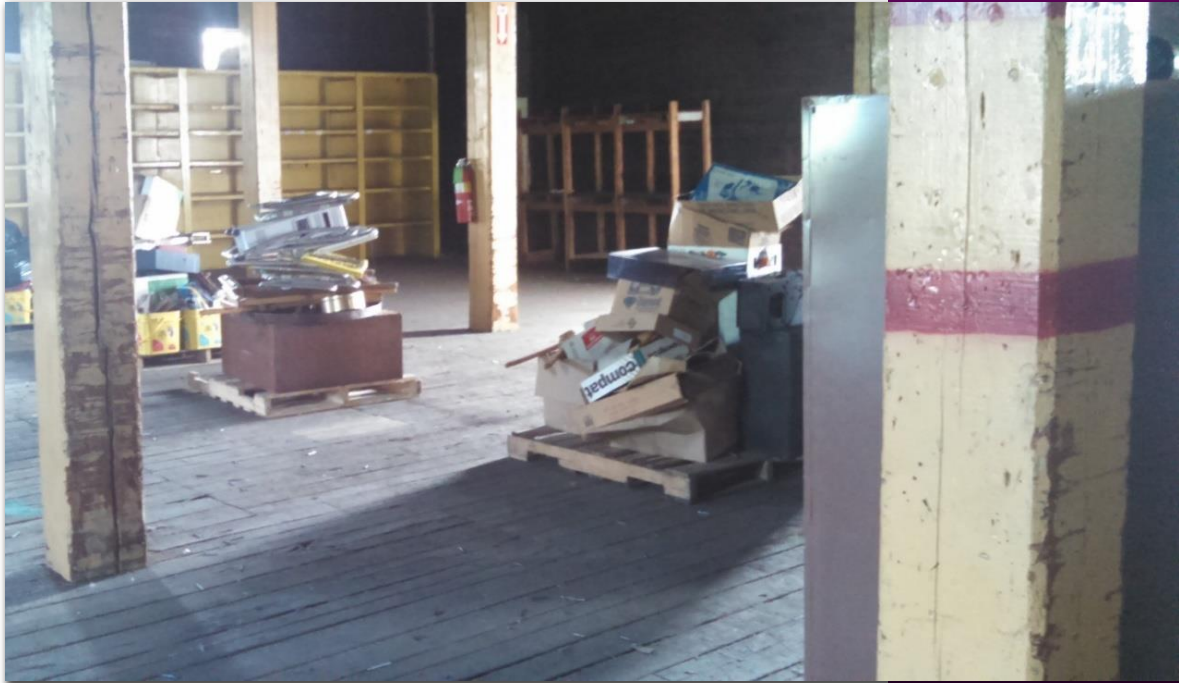
1. North East View - 2015

- New composite OSB floor sheathing was installed over the original wood plank flooring to accommodate code required life safety and structural standards.

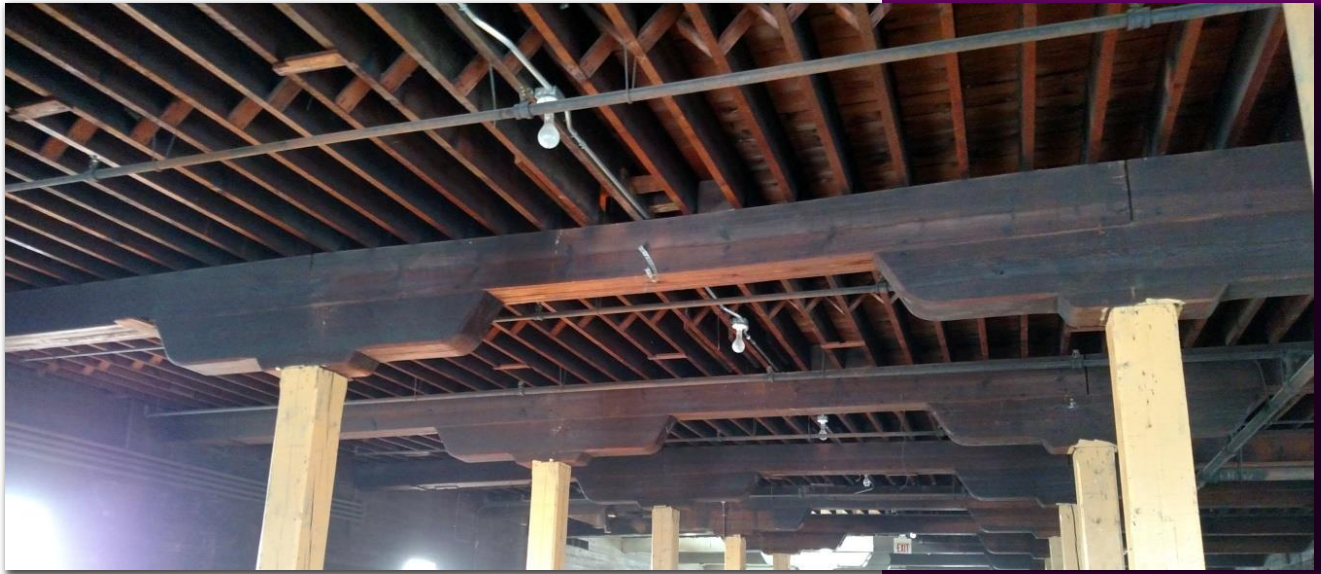
1. East View - 2015

- The original wood structure was cleaned and remains exposed throughout entire space.
- All piping, duct work and fixtures are positioned within and below the exposed wood structure above.
