**REQUEST FOR
CERTIFICATION OF
COMPLETED WORK**

**PHOTO
DOCUMENTATION OF
BUILDING AND SITE
RESTORATION
REQUIREMENTS
ACHIEVED**

**207 N. Academy
Street**

***Wisconsin Historical
Society***

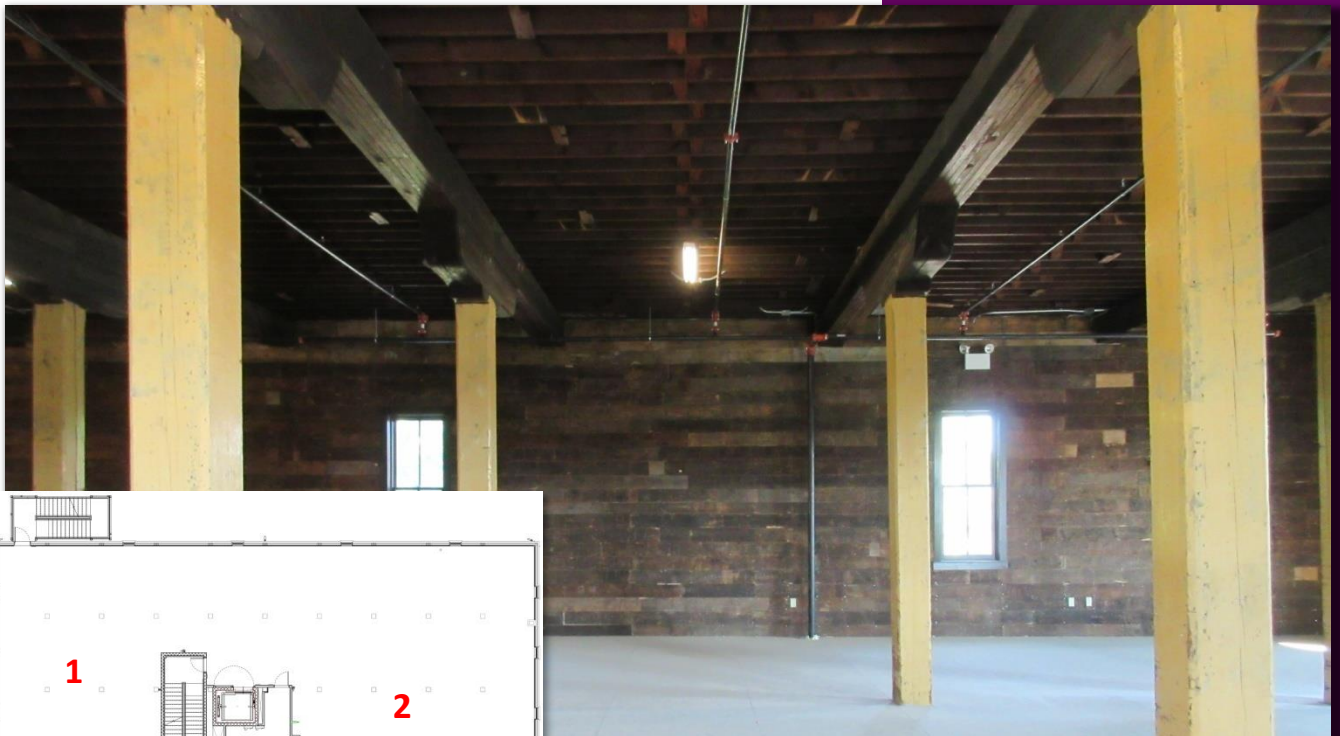
2. North View— 2016

- The original wood structure was cleaned and remains exposed throughout entire space.
- All piping, duct work and fixtures are positioned within and below the exposed wood structure above.

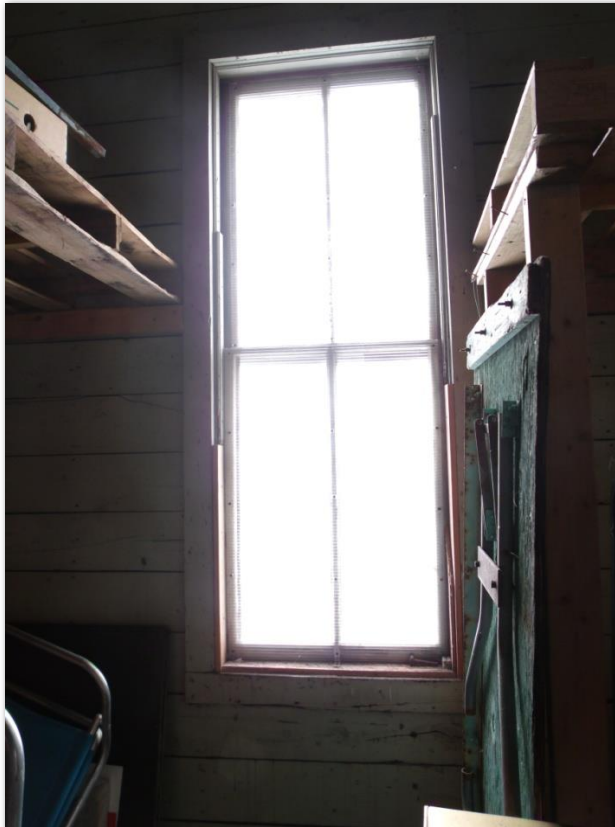
1. Window - 2015

- The original wood wall planks located on the exterior walls have been re-used in as close to their original location as possible.
- All of the existing window systems had failed and were replaced with new windows that replicate the original window design and proportions.

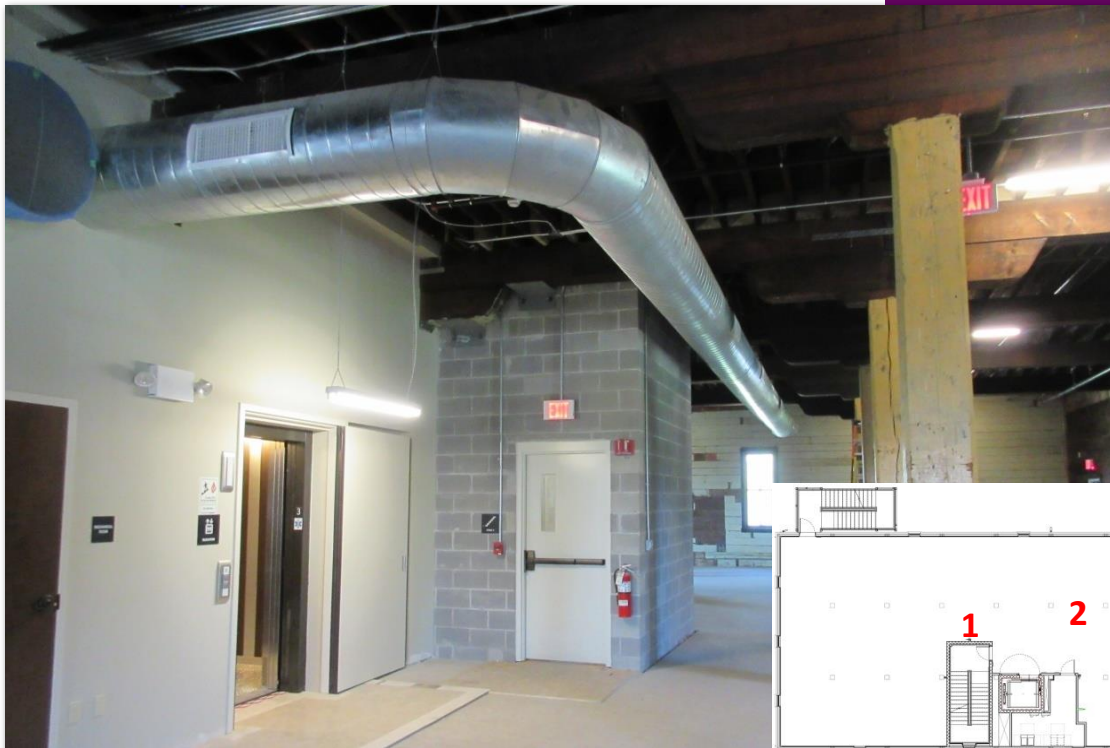
2. Elevator & Stair Core - 2016

- The new stair and elevator core are positioned alongside the original wood structure, preserving the original structural bay dimensions and north south beam locations.

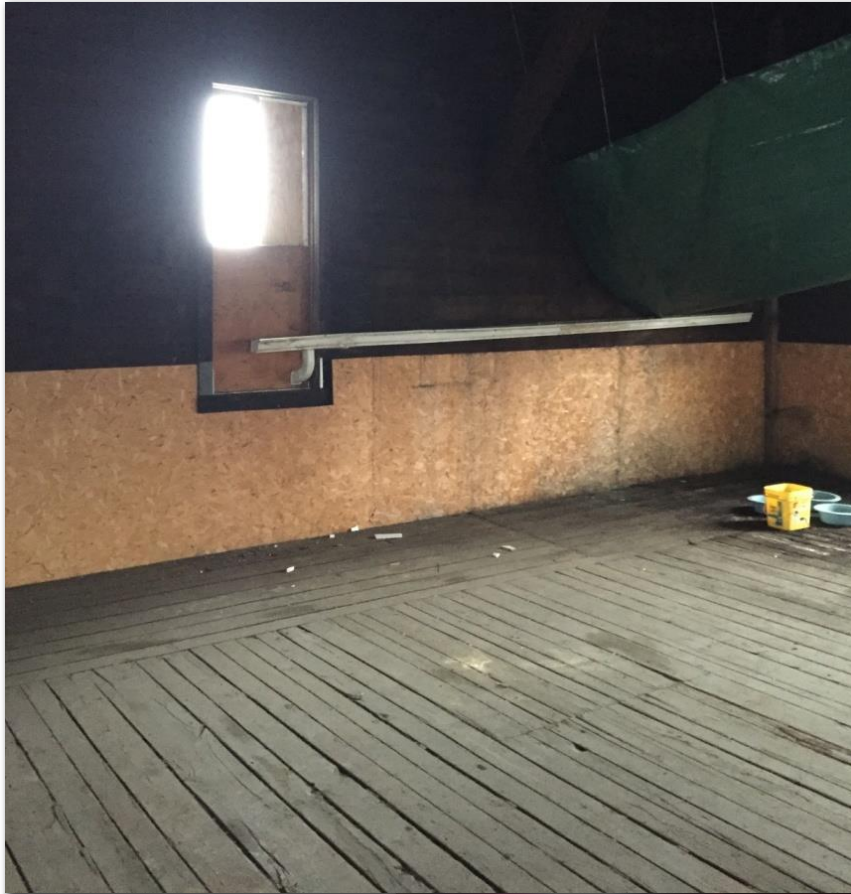
1. Wood Plank Floor - 2015

- The original wood plank flooring remains exposed throughout entire space.

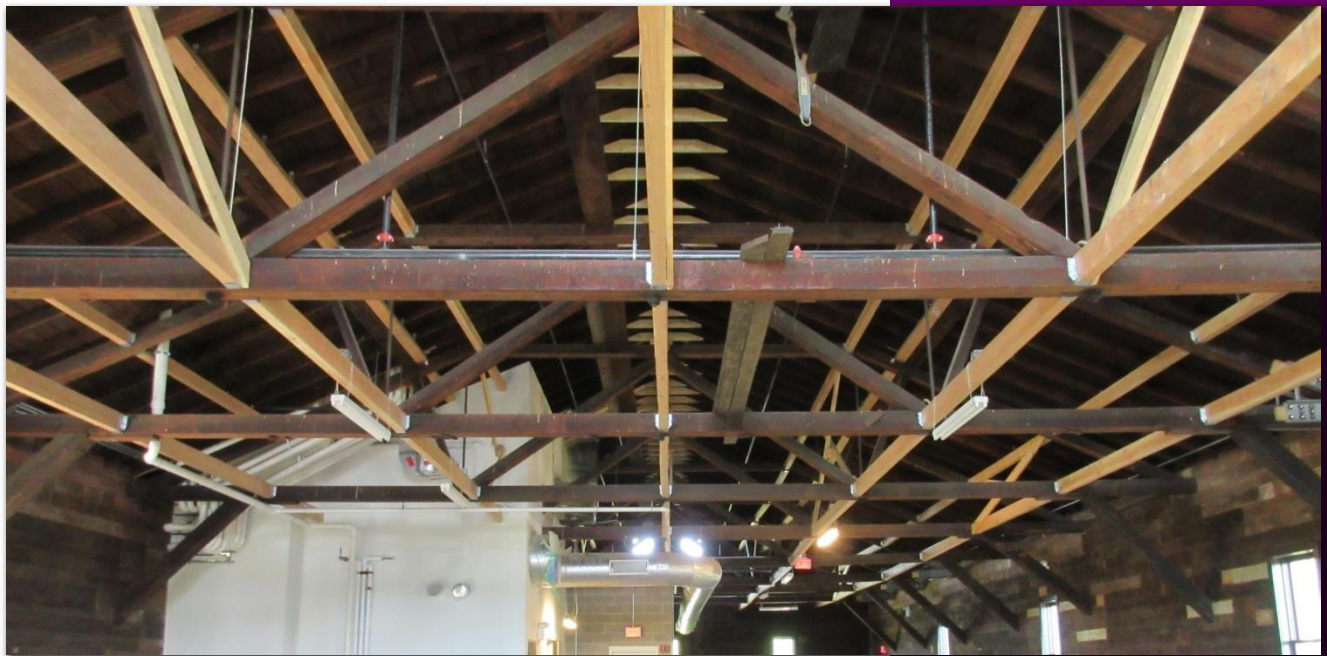
1. Roof Structure - 2016

- The original wood structure was cleaned and remains exposed throughout entire space.
- Additional wood and steel reinforcing was added to the original framing system to accommodate current structural standards.
- All of the new structural elements are represented by a lighter wood color to accentuate the original building structure.

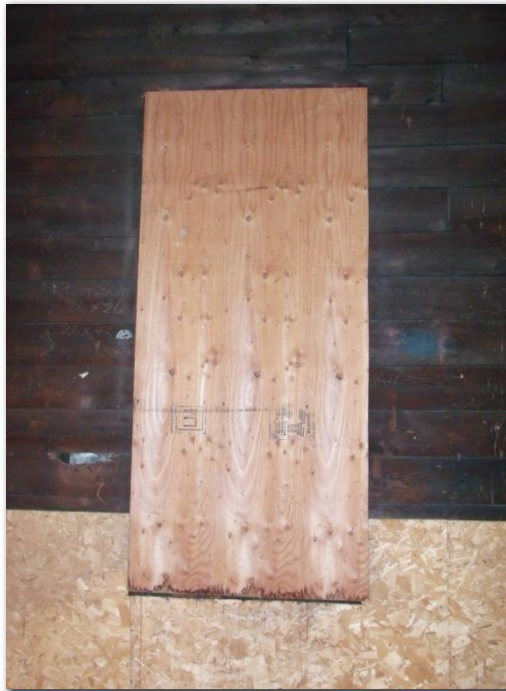
1. Wood Planks & Window Conditions - 2015

- The original wood wall planks located on the exterior walls have been re-used in as close to their original location as possible.
- All of the existing window systems had failed and were replaced with new windows that replicate the original window design and proportions.

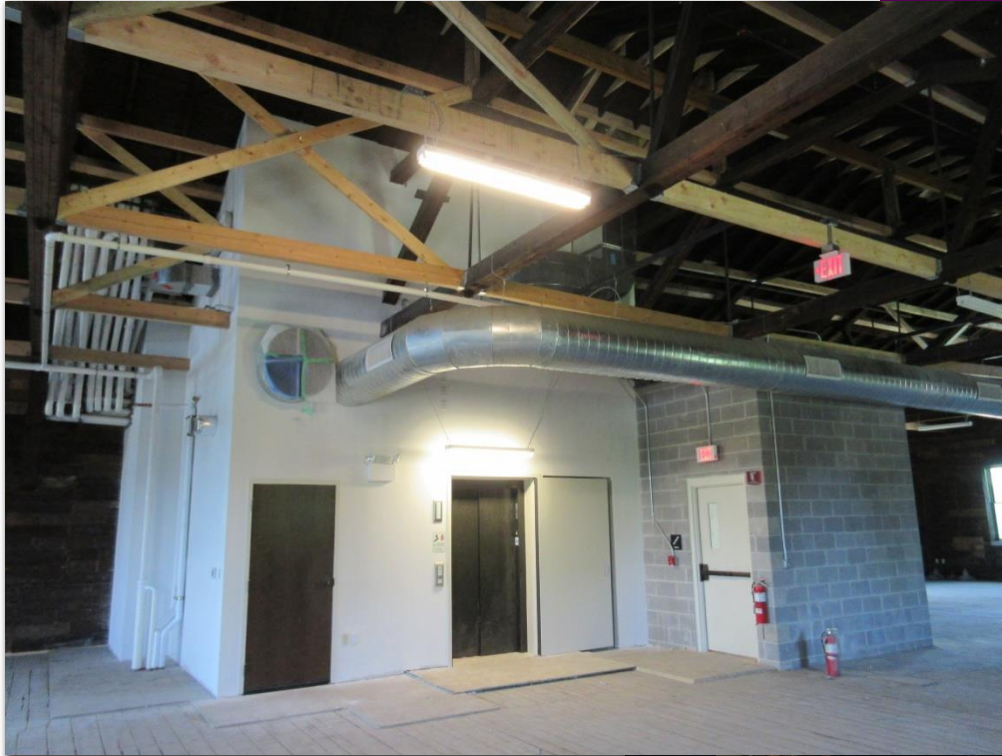
1. Elevator & Stair Core - 2016

- The new stair and elevator core are positioned below and alongside the original wood roof structure, preserving the original truss spacing dimensions and locations.
- All piping, duct work and fixtures are positioned within and below the exposed wood timber structure.
