MASONRY ADVISORY COUNCIL

To: Architects, Engineers, Builder Developers / Contractors
Ramblings and “Everything Changes with time.”

AN OLD PROBLEM WITH A NEW “MOLDY” TWIST

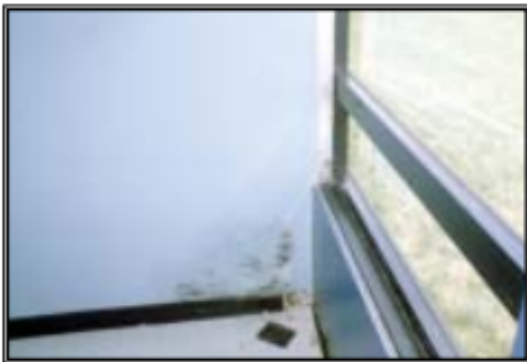
This 1 story local health care facility, built in the late 1970's had “water penetration problems” when it was repaired in the 1980's. Nowadays, it would have also necessitated a mold abatement program.

Notice the mold growing on the drywall near the floor.

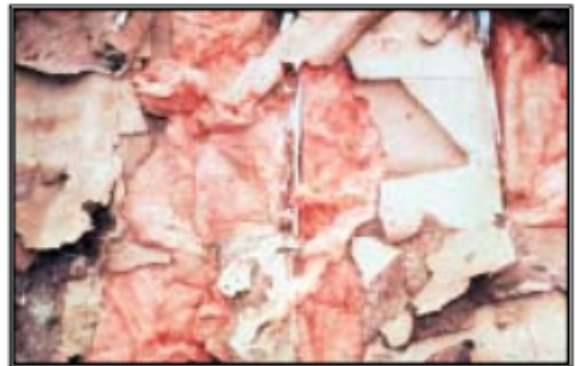
After the brick was removed one can see the corrosion of the steel studs, a black mold growing on the exterior paper of the drywall and saturated batt insulation at the base of the wall.
