MASONRY ADVISORY COUNCIL

Tolerances, Limestone Caps and Vapor Barrier / Condensation Analysis

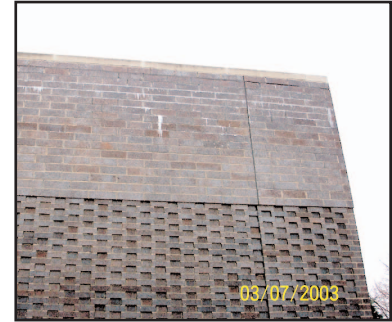
POORLY DETAILED COPING

My Bank: (Note the efflorescence, and the flush limestone cap- it should have had 1 1/2" projection or a drip edge and flashing under the cap)

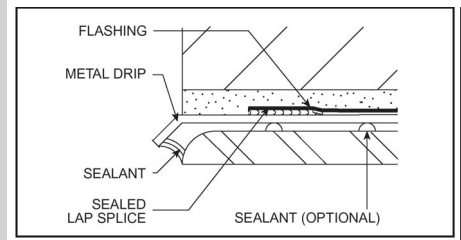
**BIA Detail, Technical Note 21B
Revised, Figure 1.**

PROPER DETAIL

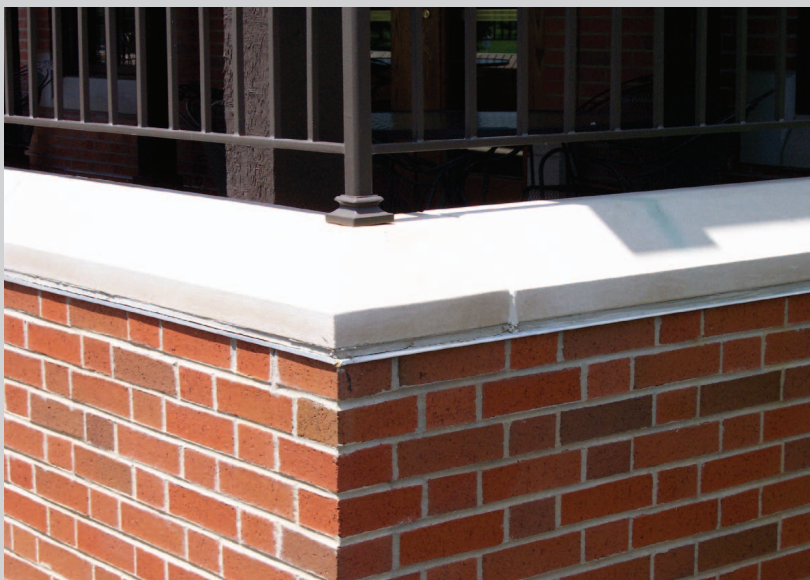
NEW FLUSH CAP WITH EXPOSED DRIP EDGE & FLASHING
