MASONRY ADVISORY COUNCIL

Tolerances, Limestone Caps and Vapor Barrier / Condensation Analysis

3 Points of Interest

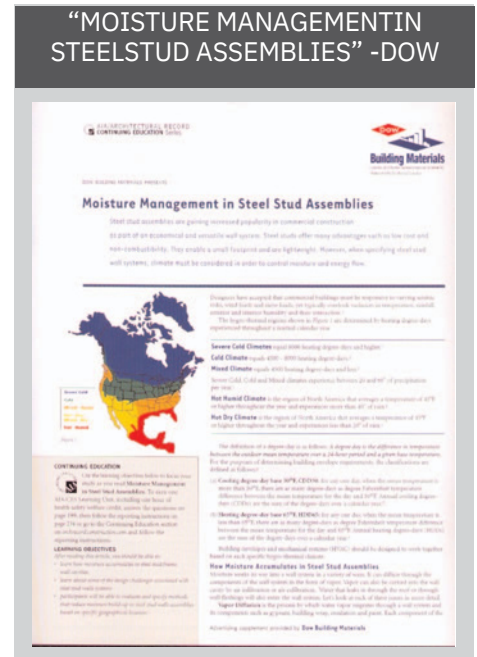
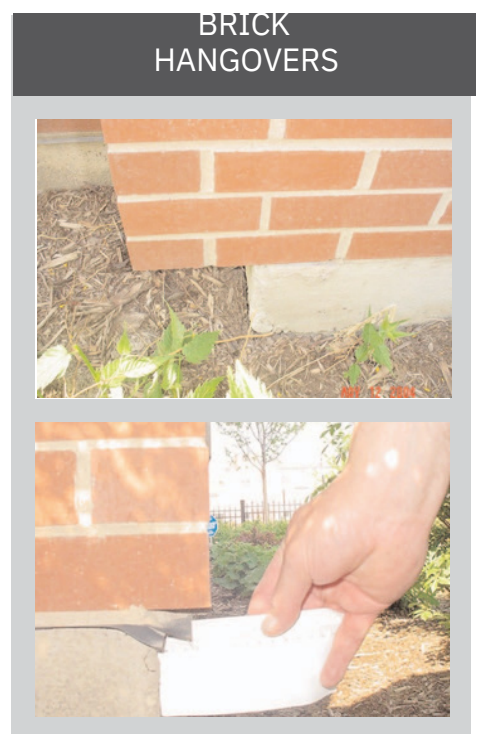
Ask your low-priced concrete contractor if they have ever heard of ACI 117 – “Tolerances for Concrete Construction”. The concrete footing, under 3.2-lateral alignment, supporting masonry, can be +/- 1/2” (if the footings are that accurate?); You know in the photo to the right something is wrong! Lately, some owners are lucky if their concrete foundation walls are on the right lot! Corbelled, unreinforced masonry can overhang a foundation wall by up to 1/3 its bed depth with 2/3 bearing on the concrete wall. [For a 3 5/8” bed depth brick that means an overhang of about 1 1/8”. This would mean 2 1/2” of the brick would be resting on the foundation.] If there is more than 1 1/8” overhanging the foundation, an engineer should be contacted to design a small angle to be bolted into the

foundation wall to support the brick.

If concrete contractors do not take enough pride in their work to frame and pour that footing and wall within ACI tolerances, then design an alternate for the next job to be constructed with a grouted and reinforced concrete masonry foundation wall. The mason contractor will know the importance of placing the foundation wall in the correct location, because in most cases they will be installing the masonry above it. Try it as an alternate, you will be pleasantly surprised, but you won’t be reinventing the wheel, our neighboring states all have a larger percentage of their foundations built with CMU’s, do they know something we don’t?

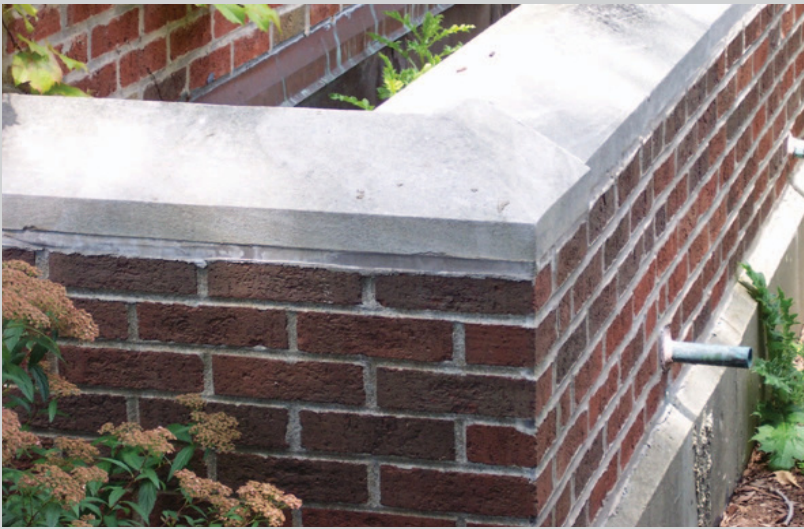
OLD CAP DETAIL

In a previous cover letter regarding flashing, I discussed self adhesive flashing and stainless steel drip edges. I showed photos of my bank (see photo on right) and BIA's Detail from Tech Note 21B (see illustration bottom right). As a follow up to this discussion while a guest at a local golf course (I'm working all the time!), I noticed the recent remodeling and careful detailing of the new masonry and the existing older brick and limestone detailing of the clubhouse. This designer was very careful in matching the original detailing, but he/she updated the limestone cap and flashing detail for the 21st century. Great work!

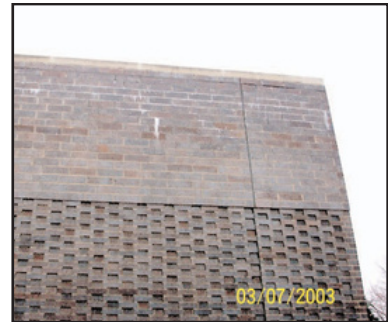
POORLY DETAILED COPING

My Bank: (Note the efflorescence, and the flush limestone cap- it should have had 1 1/2" projection or a drip edge and flashing under the cap)

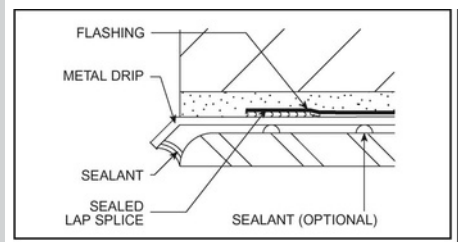
PROPER DETAIL

**BIA Detail, Technical Note 21B
Revised, Figure 1.**
