**REQUEST FOR
CERTIFICATION OF
COMPLETED WORK**

**PHOTO
DOCUMENTATION OF
BUILDING AND SITE
RESTORATION
REQUIREMENTS
ACHIEVED**

**207 N. Academy
Street**

***Wisconsin Historical
Society***

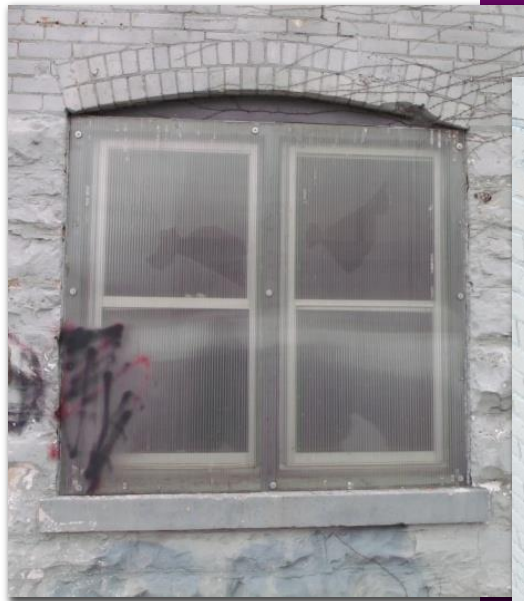
3. Window - 2015

- All of the existing window systems had failed and were replaced with new windows that replicate the original window design and proportions.

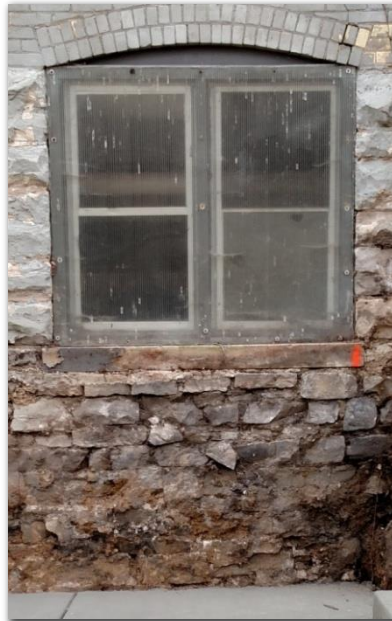
3. Window - 2015

- Two of the failed window systems were modified to accommodate the new sprinkler room entrance door and the north entry door.

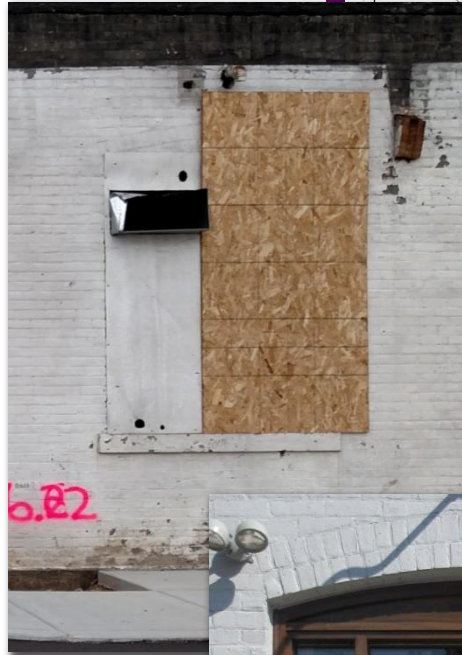
3. Original Window Opening

- The original brick façade and chimney was cleaned, repaired, tuck-pointed and re-painted gray.
- All of the original window openings on Levels 2, 3 & 4 were preserved with no modifications to the opening size or location.
- Seven of the original openings on Level 1 were preserved with no modifications to the opening size or location. Three of the original openings were modified to accommodate two new entry doors and a utility alcove entrance.

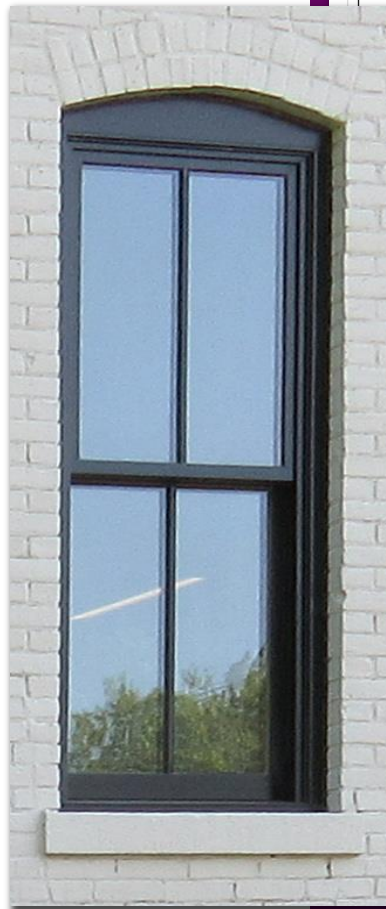
3. New Window – 2016

- All of the existing window systems had failed and were replaced with new windows that replicate the original window design and proportions.

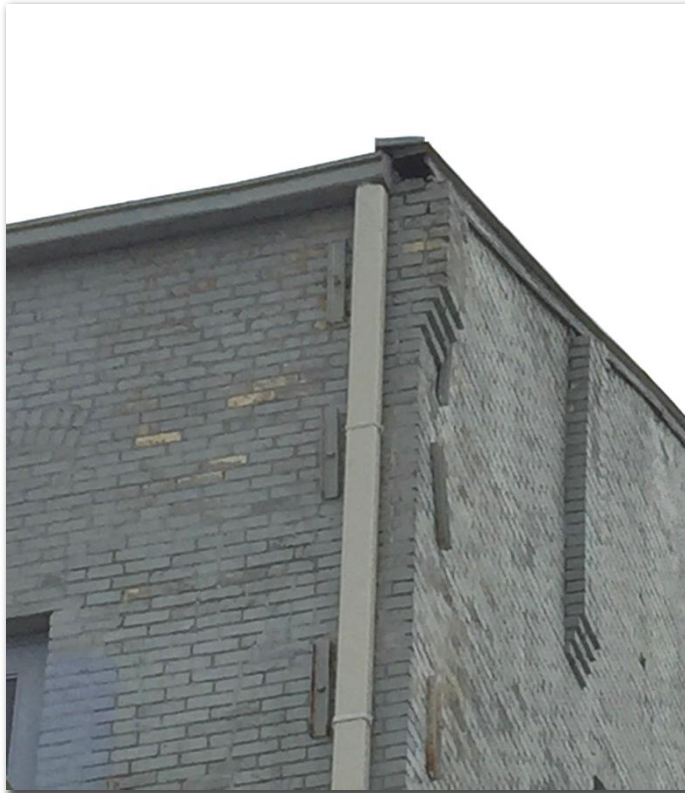
1. Wall Reinforcing - 2015

- The existing steel reinforcing located at the building corners has been preserved and re-painted gray to match the re-painted brick.

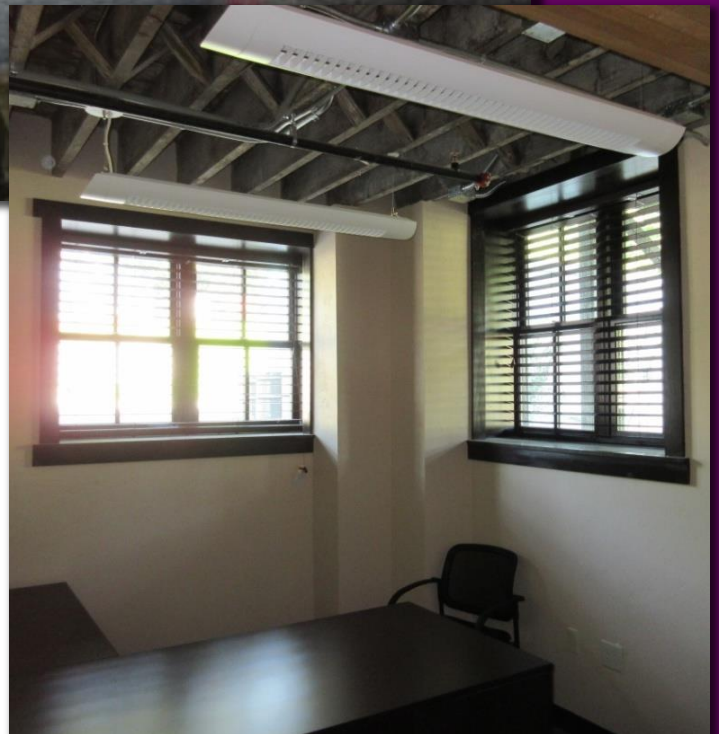
2. North West Corner - 2016

- All of the existing window systems had failed and were replaced with new windows that replicate the original window design and proportions.
- All new building elements that extend below the top of surrounding exterior windows are set back a minimum of five feet from the windows (example: light fixtures, diffusers, piping and walls) so that views are not obstructed.
- The original exterior stone walls have been finished out with metal studs, insulation and drywall in order to obtain a habitable climate controlled environment.

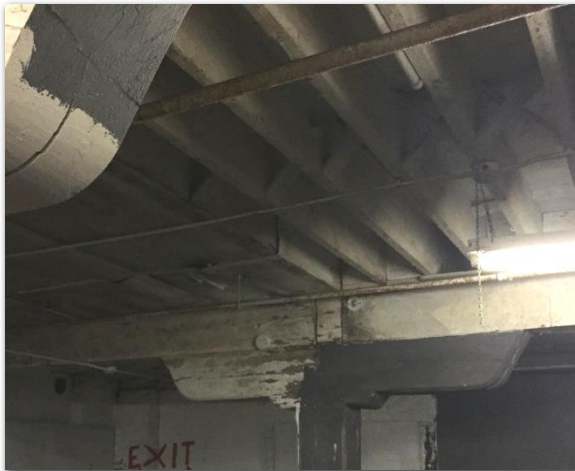
2. Exposed Wood Structure – 2015

- The original wood structural elements have been cleaned and remain exposed and prominent throughout all spaces.
- All piping, duct work and fixtures are positioned within and below the exposed wood floor structure above.

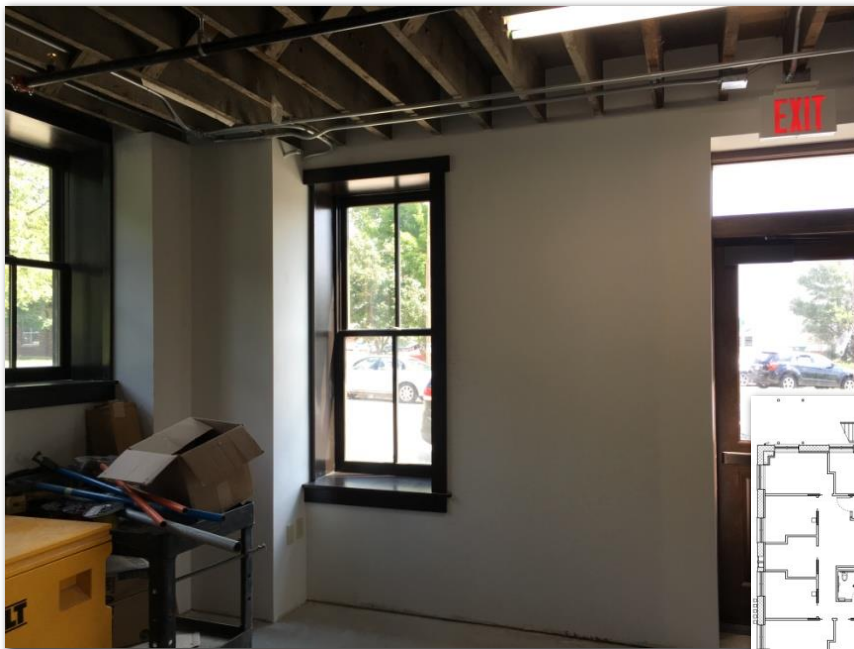
2. New Windows - 2016

- All of the existing window systems had failed and were replaced with new windows that replicate the original window design and proportions.
- All piping, duct work and fixtures are positioned within and below the exposed wood structure.

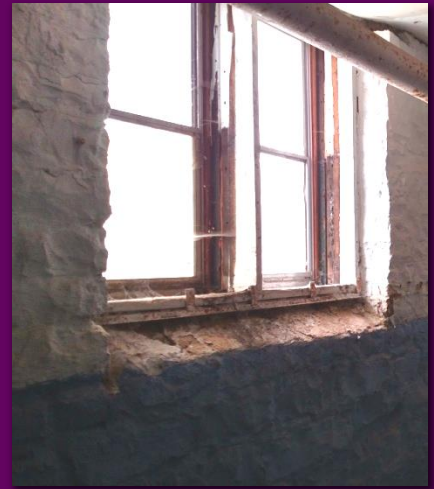
1. Stone Walls - 2015

- The original exterior stone walls have been finished out with metal studs, insulation and drywall in order to obtain a habitable climate controlled environment.
- The positioning of new clerestory windows in the Waiting Area provides a visual connection between neighboring developed spaces.

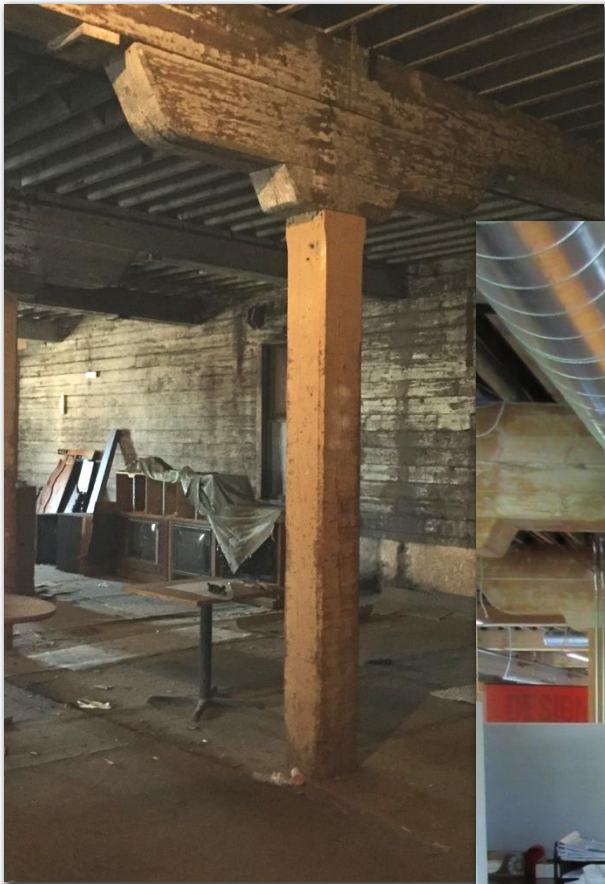
1. Wood Structure - 2015

- The original wood structure was cleaned and remains exposed throughout entire space.
- All piping, duct work and fixtures are positioned within and below the exposed wood floor structure above.

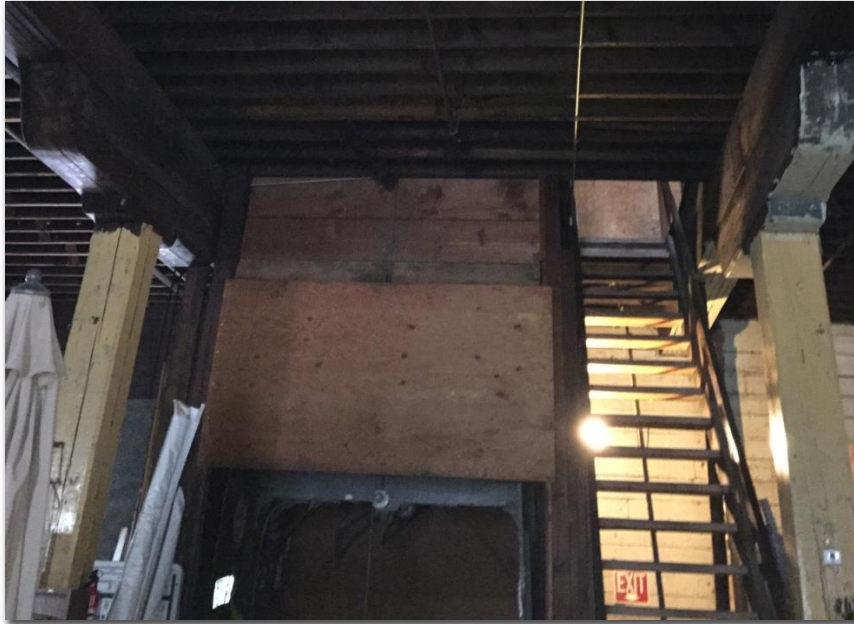
1. Elevator & Stair Core - 2015

- The new stair and elevator core are positioned alongside the original wood structure, preserving the original structural bay dimensions and north south beam locations.
