MASONRY ADVISORY COUNCIL

Tolerances, Limestone Caps and Vapor Barrier / Condensation Analysis

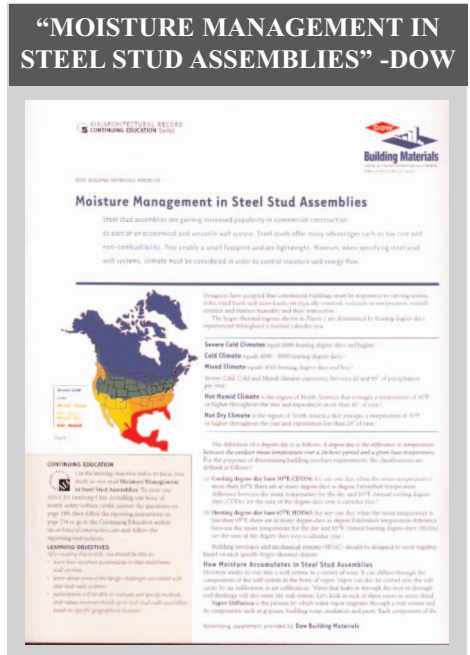
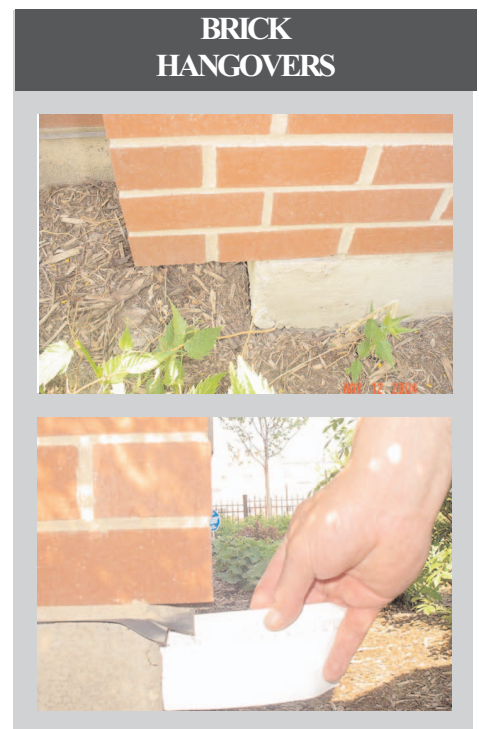
Ask your low-priced concrete contractor if they have ever heard of ACI 117 – “Tolerances for Concrete Construction”. The concrete footing, under 3.2-lateral alignment, supporting masonry, can be +/- 1/2”(if the footings are that accurate, why can’t the placement of forms and concrete walls above them be as accurate?); You know in the photos to the right something is wrong! Lately, some owners are lucky if their concrete foundation walls are on the right lot! Corbelled, unreinforced masonry can overhang a foundation wall by up to 1/3 its bed depth with 2/3 bearing on the concrete wall. [For a 3 5/8” bed depth brick that means an overhang of about 1 1/8”. This would mean 2 1/2” of the brick would be resting on the foundation.] If there is more than 1 1/8” overhanging the foundation, an engineer should be contacted to design a small angle to be bolted into the foundation wall to support the brick.

If concrete contractors do not take enough pride in their work to frame and pour that footing and wall within ACI tolerances, then design an alternate for the next job to be constructed with a grouted and reinforced concrete masonry foundation wall. The mason contractor will know the importance of placing the foundation wall in the correct location, because in most cases they will be installing the masonry above it. Try it as an alternate, you will be pleasantly surprised, but you won’t be reinventing the wheel, our neighboring states all have a larger percentage of their foundations built with CMU’s, do they know something we don’t?
