## SINGLE-WYTHE MASONRY DETAILED AS A VENEER SOLVES DESIGN AND CONSTRUCTION CHALLENGES

## FLASHED LOADBEARING WALLS

BY WILLIAM D. PALMER JR.

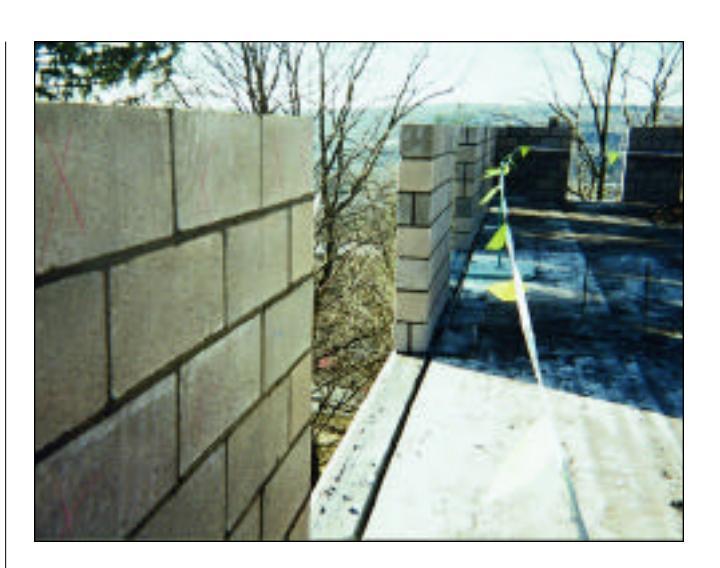
Top: These thirdfloor walls show construction using 8-inch block built without scaffolding.

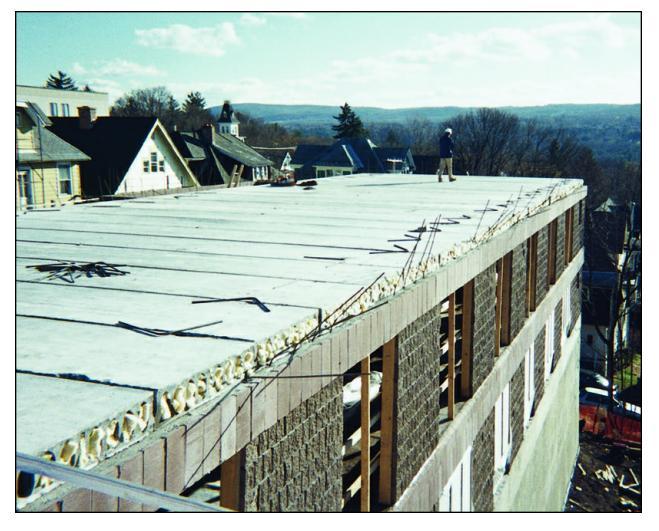
Top: Note the insulation within the plank cores and the reinforcement extending from the walls below.

Besides the advantage of creating a drainage wall, this system has two layers of insulation, the rigid board layer against the back of the blocks and a fiberglass batt layer in the steel-stud wall. This combination provides a very high thermal rating for the wall, which is further improved by insulation in the cores at the ends of the precast floor planks.

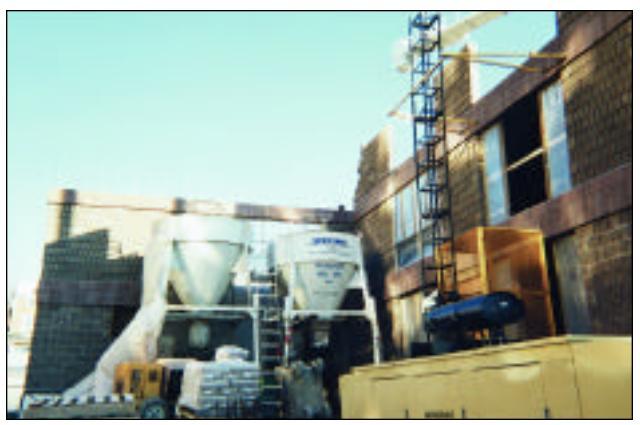
Middle: This small area provided the staging for delivery to the masons of mortar and grout.

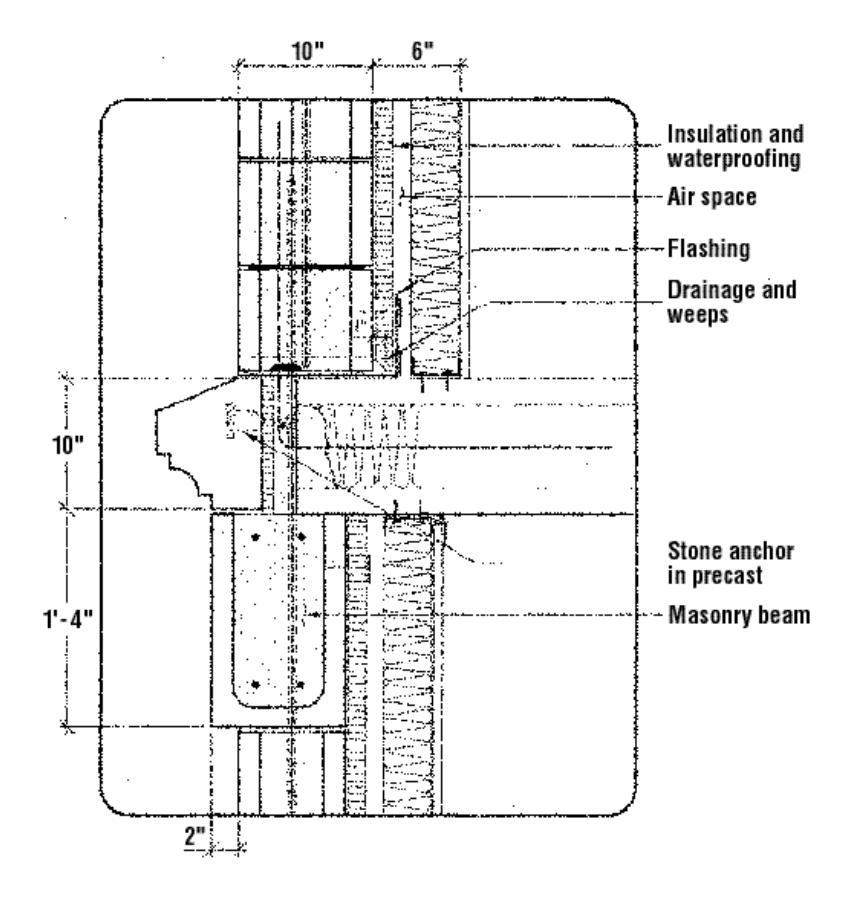
Bottom: The exterior bearing wall and the floor system are tied together at each floor level.

At each floor level, reinforcing steel crosses through the bond beam, tying together the floor planks and the walls above and below. At the building's ends, the walls parallel to the planks are tied to the planks with a clip angle. This was the best way to create a shear connection between the walls and the plank, given the large camber in the 33-foot planks. Trying to frame a 10-inch cambered plank into the masonry wall would have been a major construction problem but was simplified by the clips.
