June 2017

How to install Flashing & Weeps

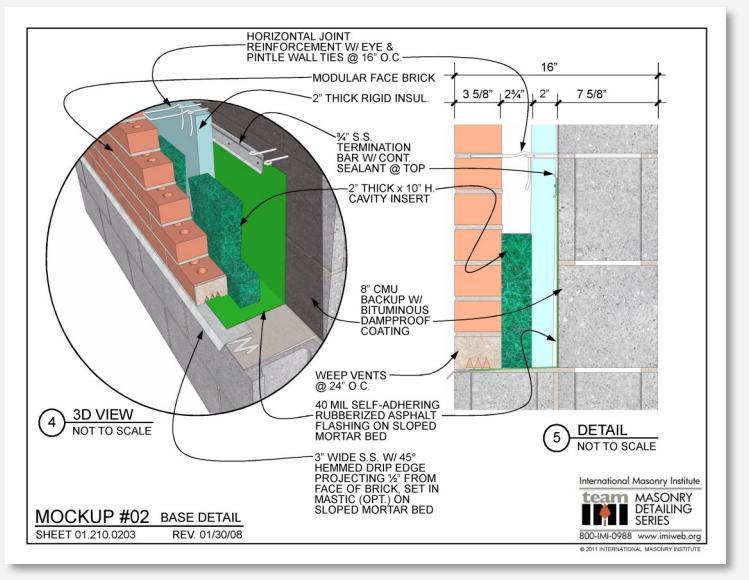
The design intent of a cavity wall is not to hold water but to resist water. The recommendation

for weep holes going forward should be to either leave the head joint open, use a weep vent or a weep mesh vent. (see pictures) Rope weeps may contribute to moisture problems, as was the case in this project.

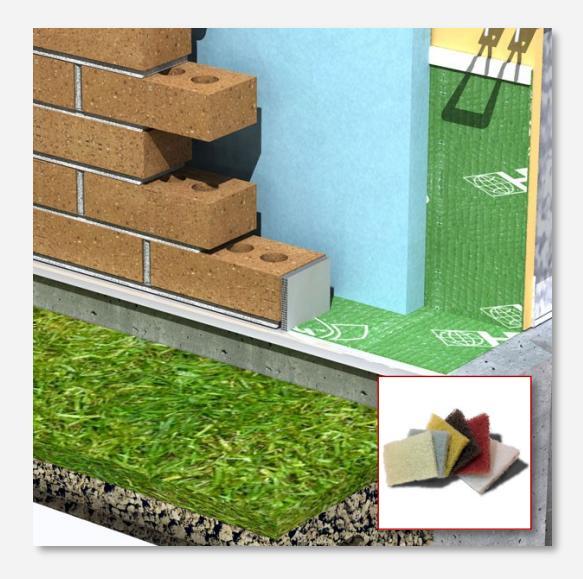
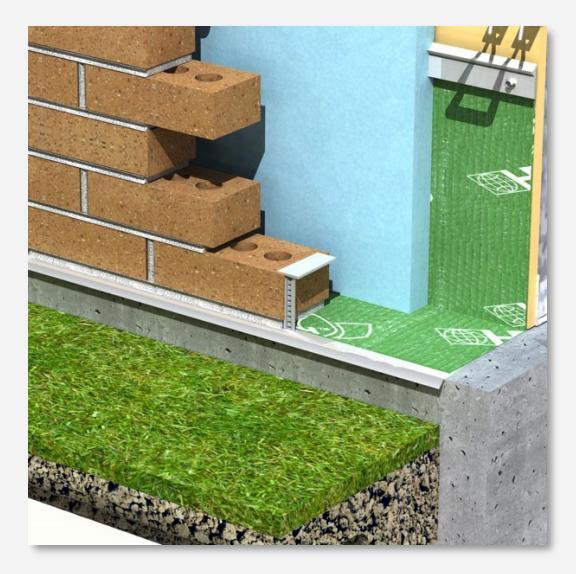
The flashing is probably one of the most important parts of a masonry wall. Flashing needs to be installed correctly and per the manufacturer's instructions. A stainless steel drip edge needs to be caulked to the foundation. It is typical to prime the surface before a sticky backed 30 or 40 mil flashing, with mastic installed at laps per manufacturer's instruction get attached to the substrate. A termination bar needs to be installed (that means anchored per manufacturer's instructions and caulked properly) to insure the flashing stays in place. It is necessary to install a mortar collection device at the base of the wall and at the heads of openings so the weep vents can work correctly and drain. The weep vents need to be spaced per the TMS 402/602 Code.
