What's happening

IN MASONRY

February 2018

Masonry & Efflorescence

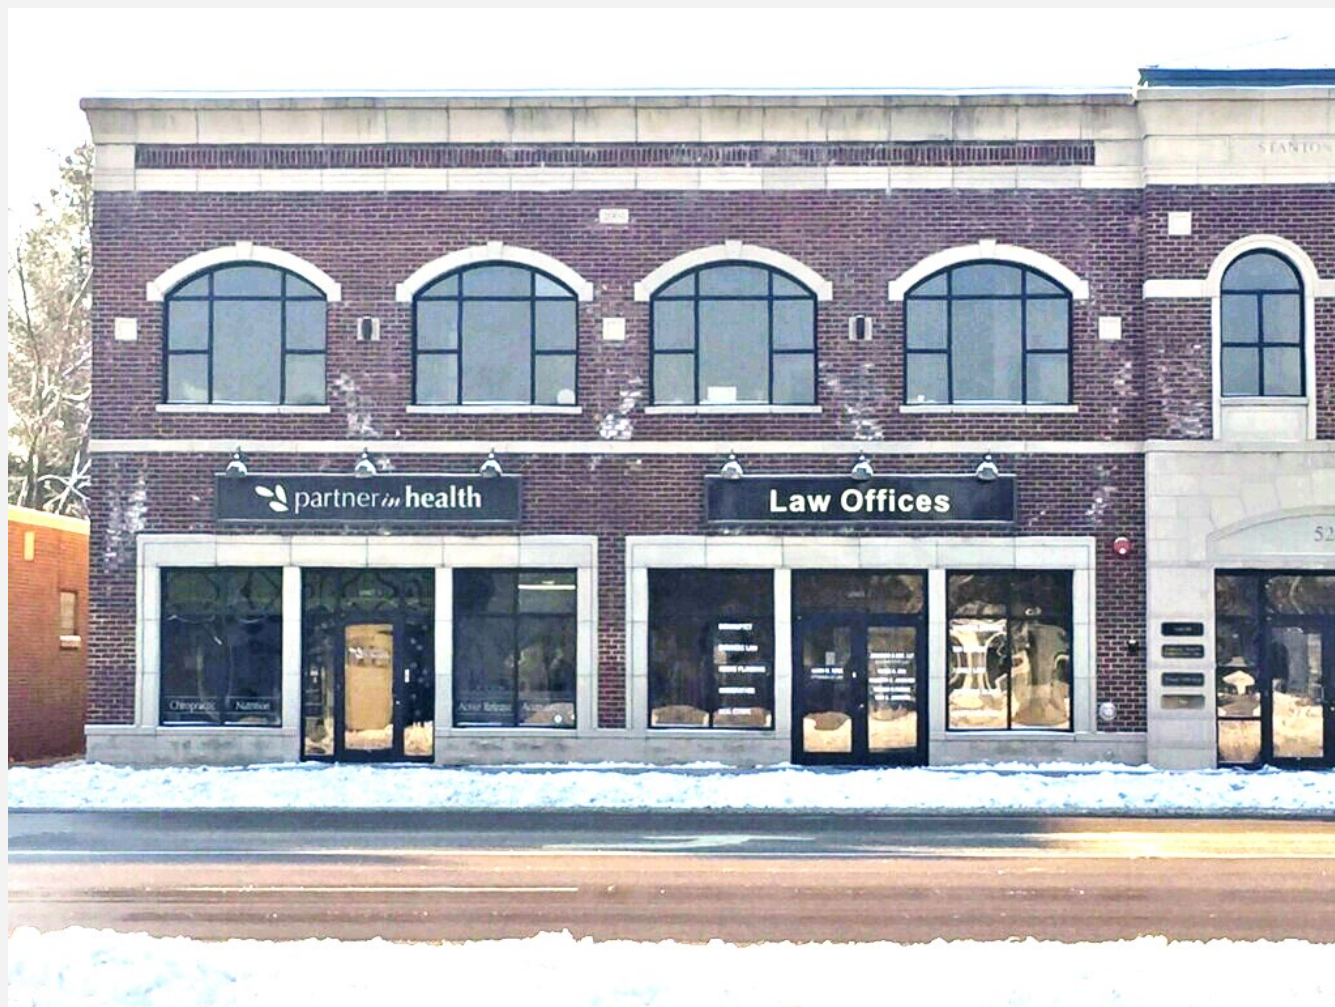
Efflorescence appears as a white crystalline deposit on face brick or concrete block. These deposits may be efflorescence, water-soluble salts that occasionally occur on the surface of masonry. Although undesirable, efflorescence is usually not harmful to masonry. Efflorescence is relatively easy to clean from masonry.

The cause of efflorescence, the water soluble salts, may come from the materials, the brick, the mortar, cement in the mortar, lime in the mortar, mortar additives, backing materials, soil from below grade or some adjacent material. Along with the material, there must be a source of water in contact with the salts for a period of time sufficient to dissolve them. The masonry must have a pore structure that allows the migration of salt solutions to the surface or other locations where evaporation of water can occur.

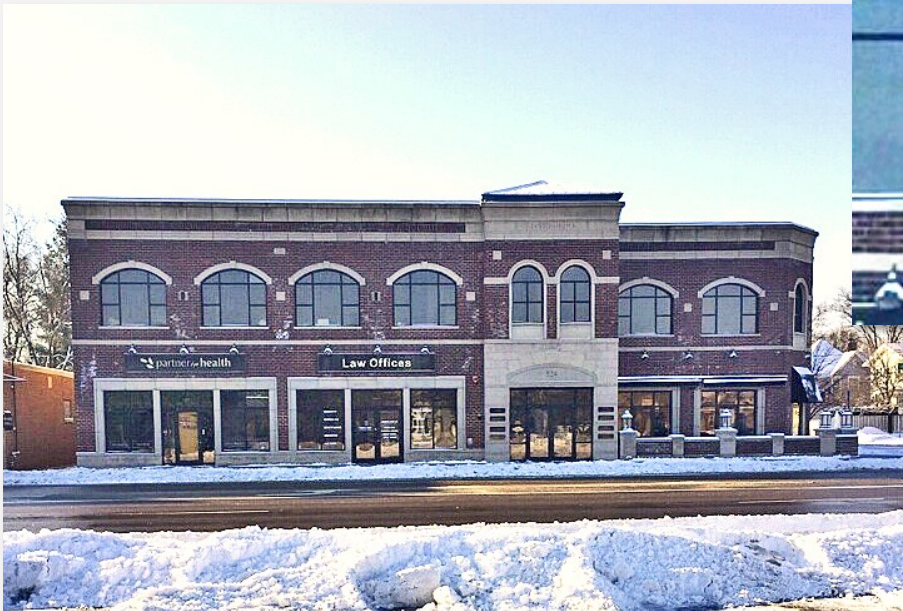
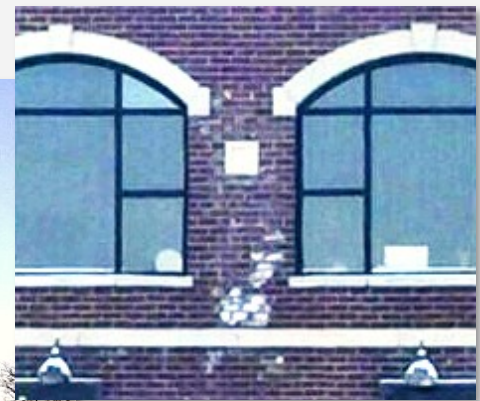
Efflorescence can be seen on buildings from a distance, while a close up of brick reveals uneven color on the surface of the brick.
