April 2021

## Efflorescence or Why is my building all white?

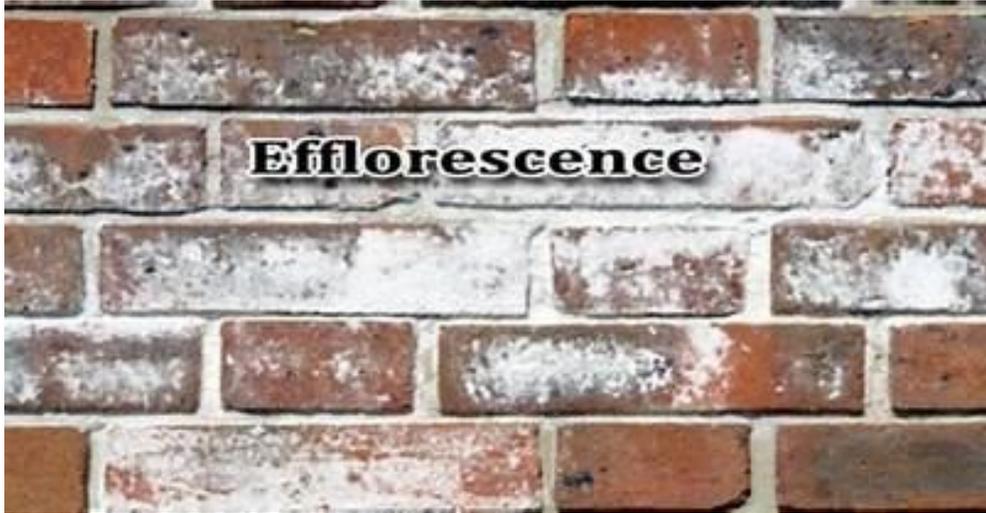
Many buildings at some point in their history exhibit some form of efflorescence. What is efflorescence?

Efflorescence is a white chalky substance that often occurs on the surface of a masonry wall and it is comprised of water-soluble salts. When soluble salts are dissolved in water, this becomes a salt solution. The salt solution then moves to the surface of the masonry wall where the water evaporates and leaves the salts on the surface, that is efflorescence.

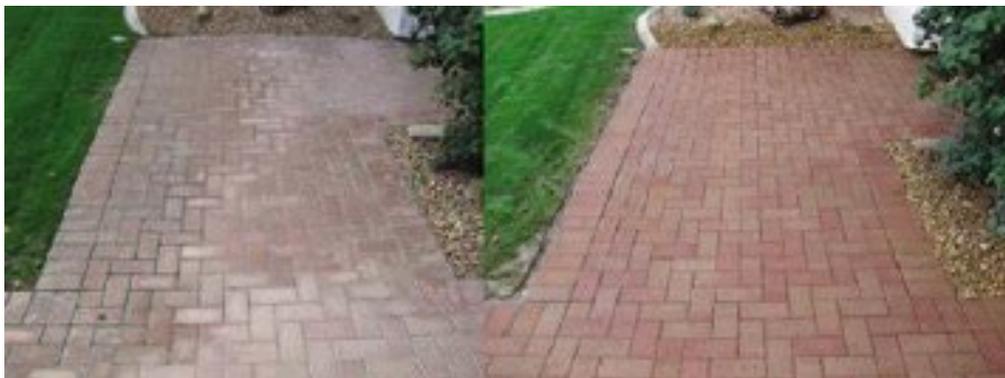
## Before and after cleaning of efflorescence.

The good news about efflorescence is that it can usually be cleaned off from the masonry wall using a good masonry cleaner. In some instances, the rain alone can wash this stain away.

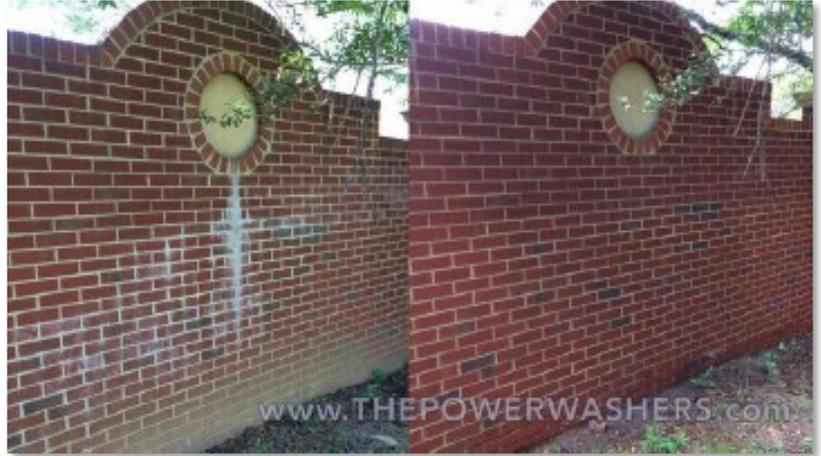
If efflorescence occurs in a building in the first year of its existence, it is referred to as “New Building Bloom”! There is a lot of moisture in the walls and entire structure of a newly completed building, and it may take that first year with the heat on for the moisture to escape the walls and dissipate.
