## Efflorescence or Why is my building all white?

Published by the Masonry Advisory Council  
1440 Renaissance Drive #340,  
Park Ridge, IL 60068

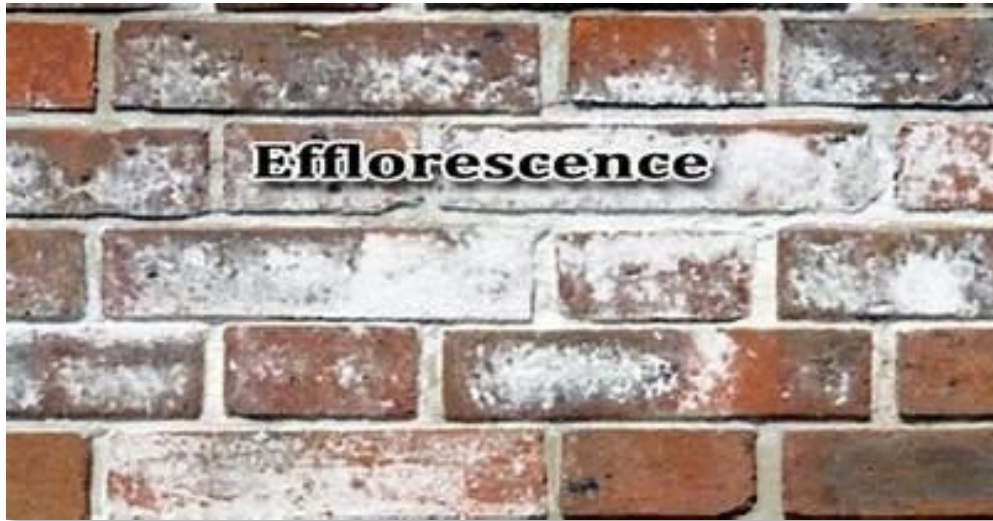
Efflorescence is a white chalky substance that often occurs on the surface of a masonry wall and it is comprised of water-soluble salts. When soluble salts are dissolved in water, this becomes a salt solution. The salt solution then moves to the surface of the masonry wall where the water evaporates and leaves the salts on the surface, that is efflorescence.

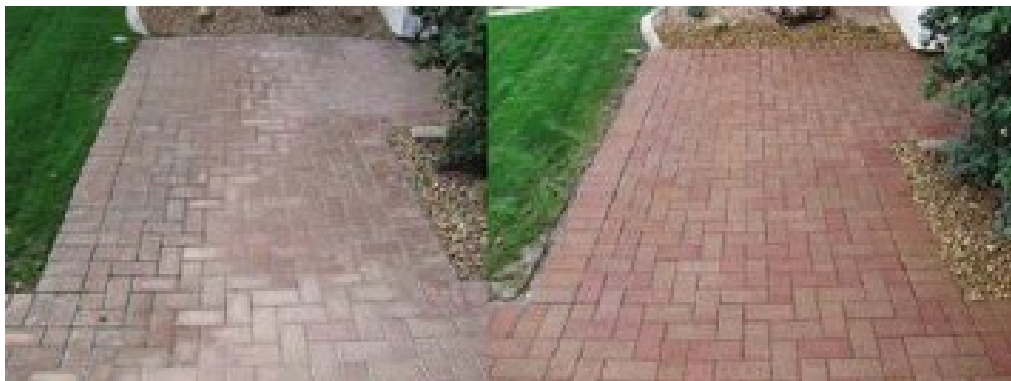
## Before and after cleaning of efflorescence.

The good news about efflorescence is that it can usually be cleaned off from the masonry wall using a good masonry cleaner. In some instances, the rain alone can wash this stain away.
